## ASBESTOS CLEARANCE CERTIFICATE

#0035-0001\_15052021

| Site address of work being carried out: | Rockhampton Girls Grammar School<br>Denham St, Rockhampton QLD 4700 |
| Details of specific asbestos removal work area(s): | Removal of asbestos external wall coverings utilizing non-friable removal techniques. From.<br>Building breezeway 10-11 |

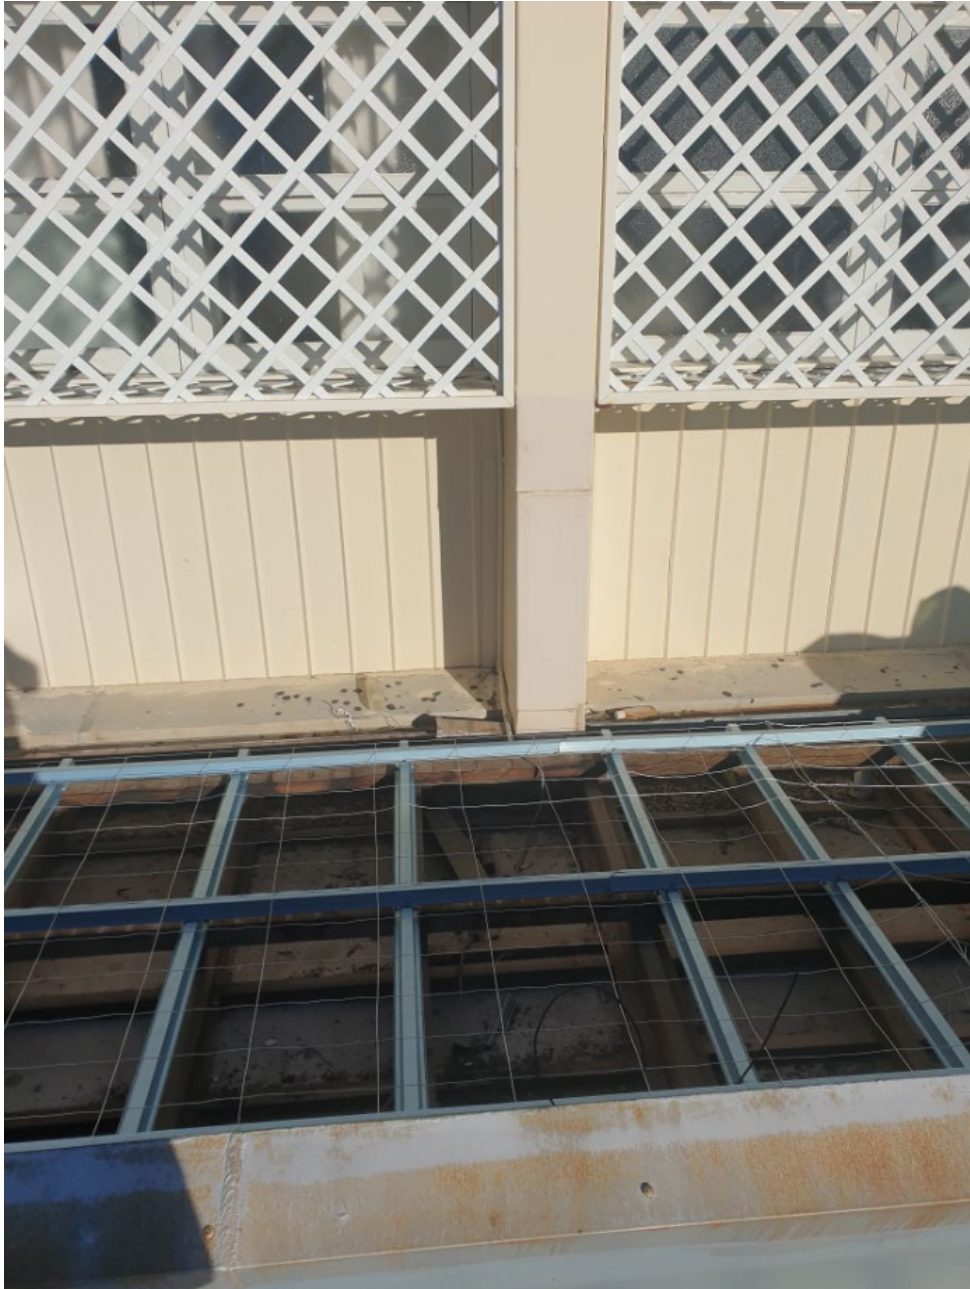
Photo 1

Prior to removal.

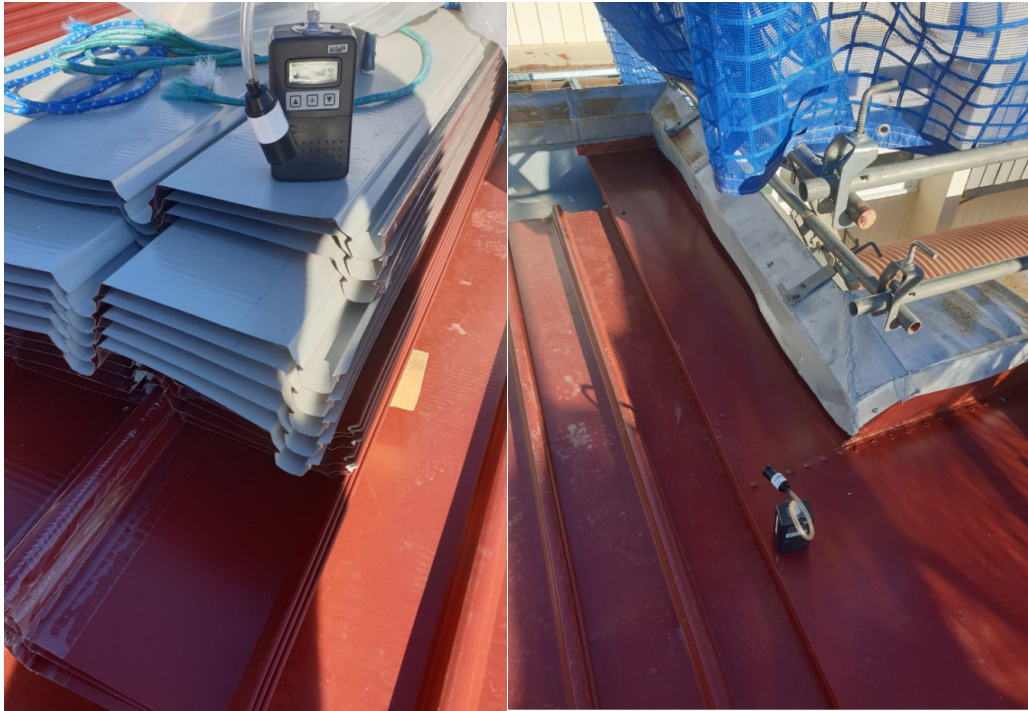
Photo 2-3

| Clearance Inspection Notes | |
|---|---|
| 8. | Air monitoring pumps strategically placed in the removal area |

Air monitoring pumps.

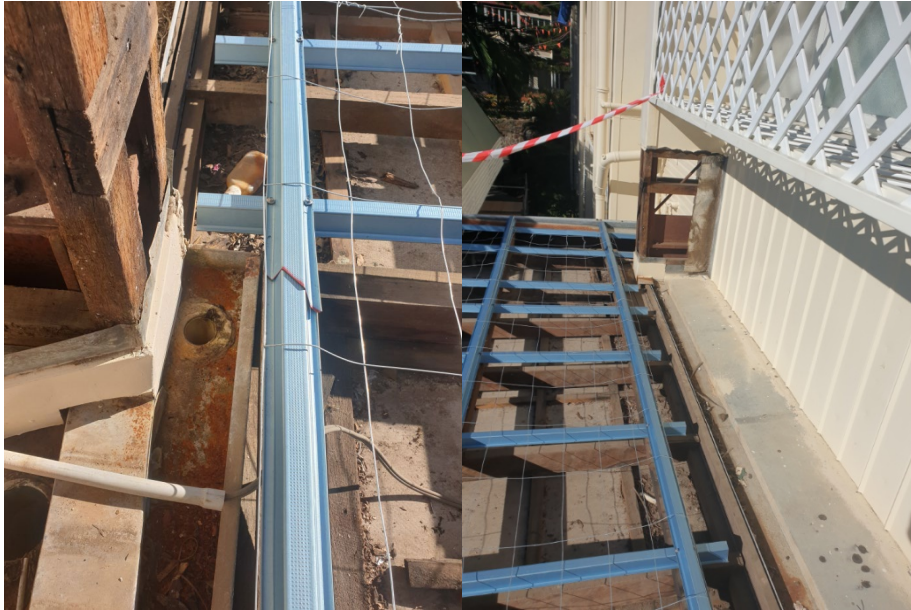
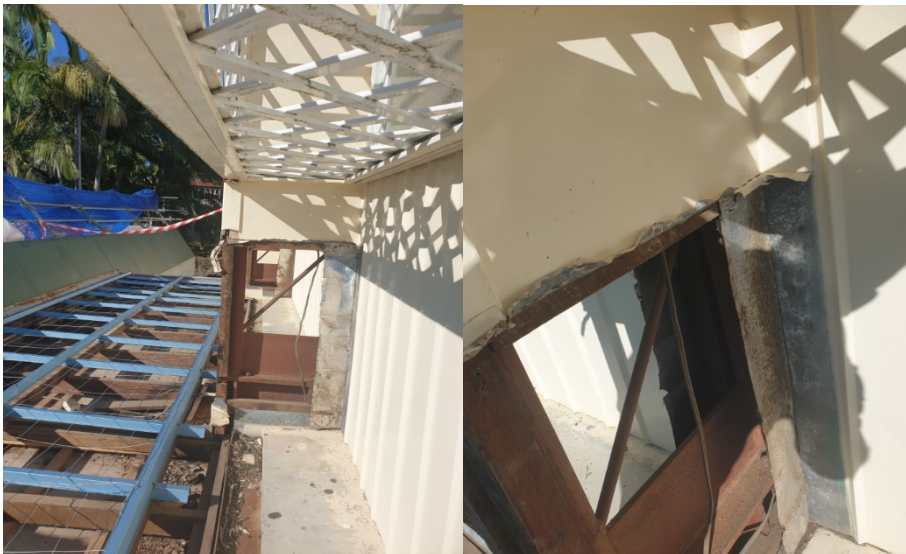
Photo 4-5-6-7

At time of clearance.

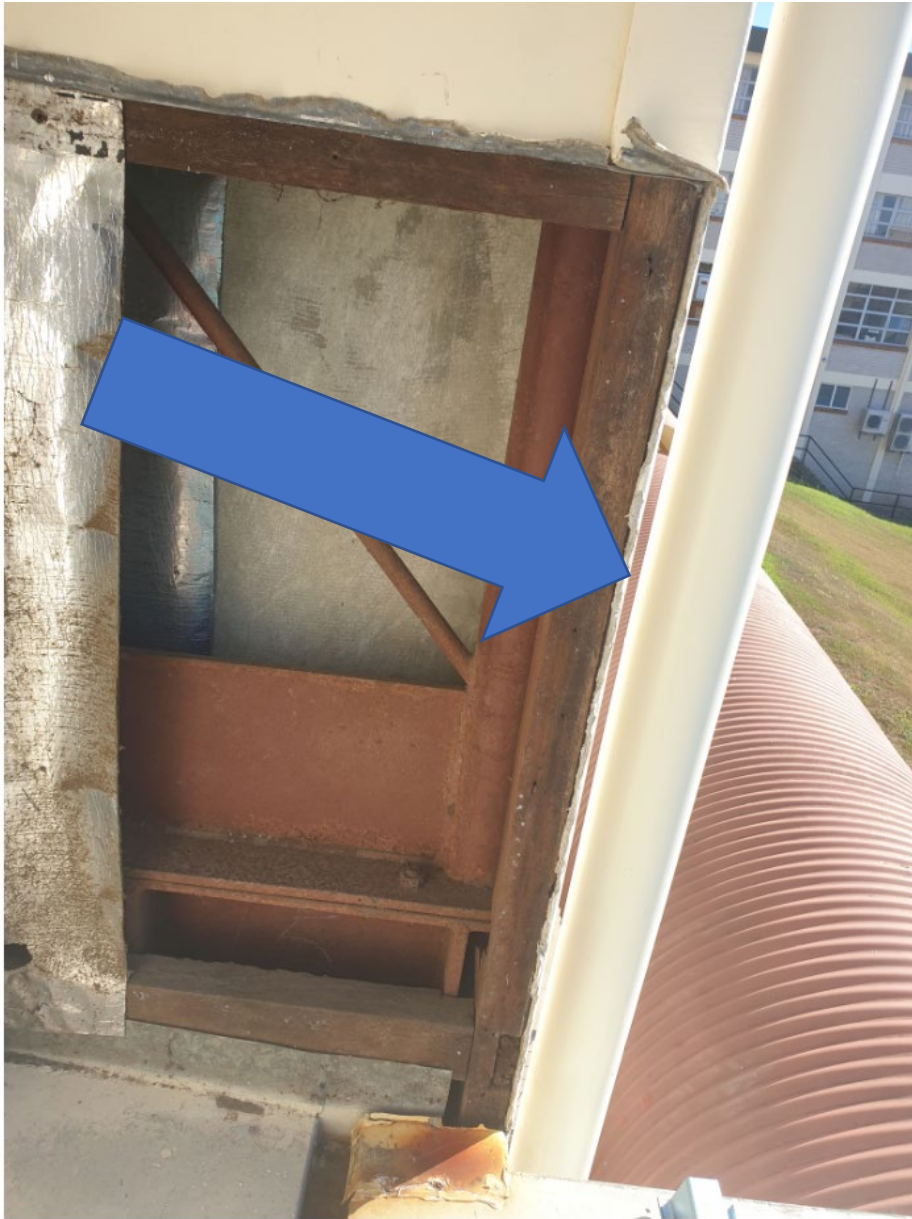
Photo 8

Northern elevation eastern face has been left in situ the exposed edging has been immersed with a PVA solution

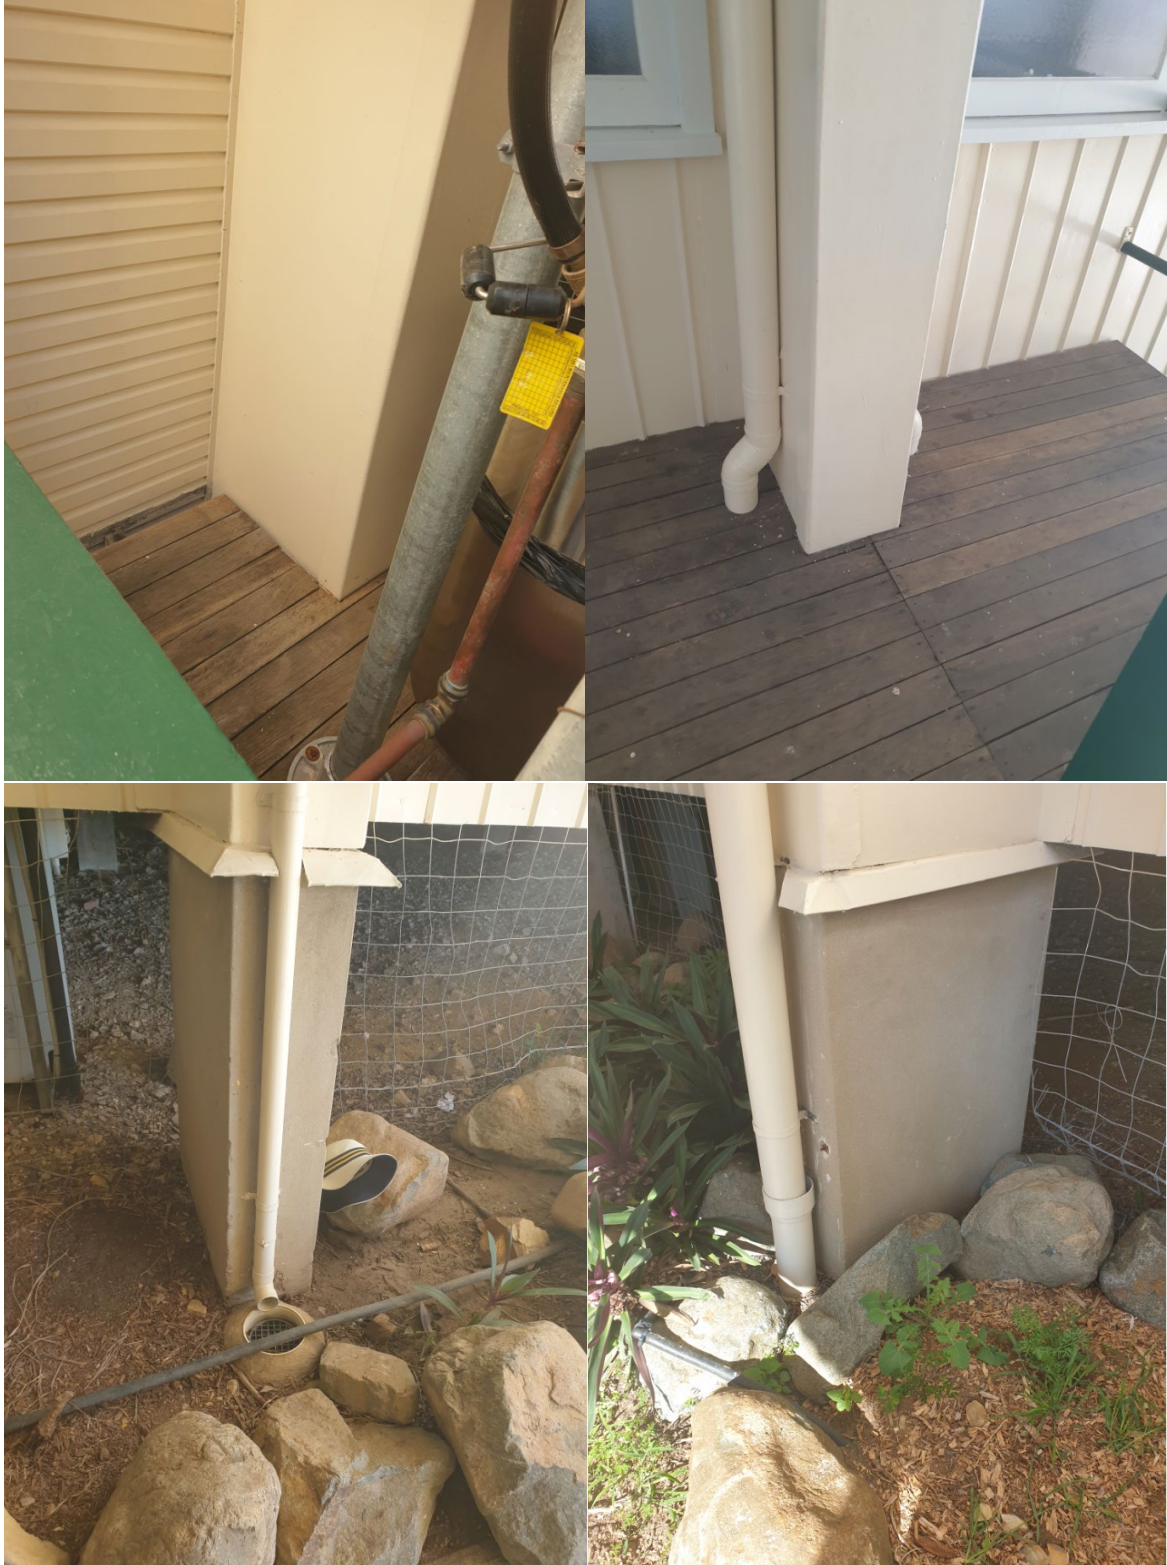
Photo 9,10,11,12

At time of clearance
