## 2024 ASBESTOS REGISTER – FLORENCE HOUSE, Rockhampton Girls Grammar School

Date of register: 06/06/2024

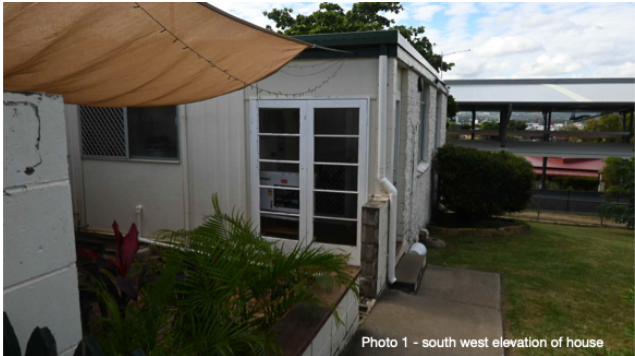
Photo 1 - south west elevation of house

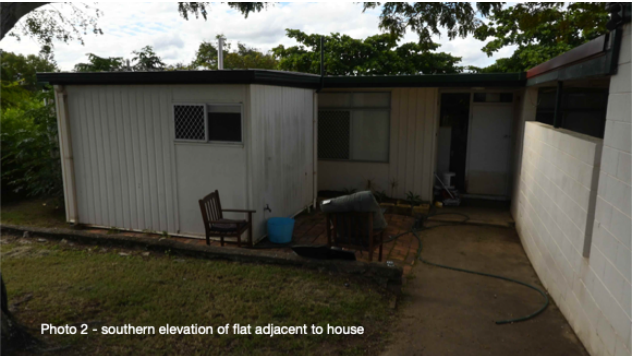
Photo 2 - southern elevation of flat adjacent to house

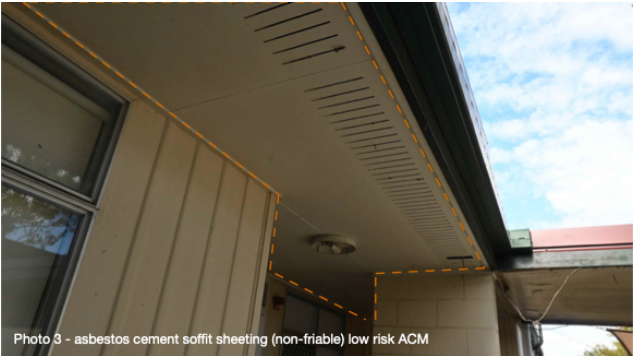
Photo 3 - asbestos cement soffit sheeting (non-friable) low risk ACM

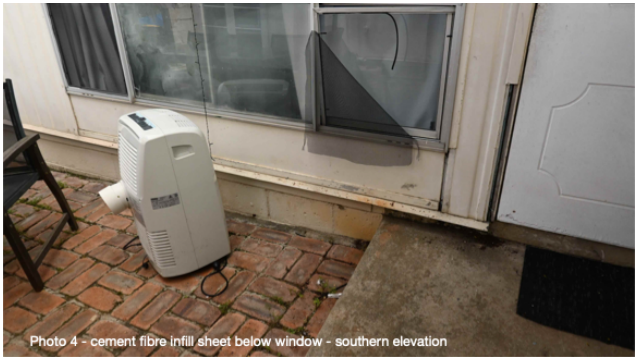
Photo 4 - cement fibre infill sheet below window - southern elevation

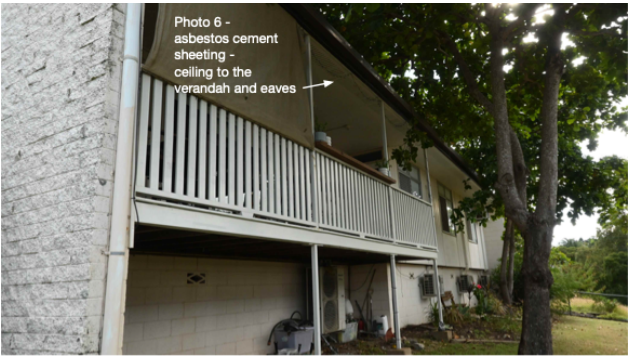
| Date | Sample No. | Type of material identified or assumed and amount<br>(Cross-sectional areas are estimates – measure before quoting) | Friable or non-friable asbestos | Condition of asbestos | Specific location of identified or assumed asbestos | Notes |
|---|---|---|---|---|---|---|
| 06/06/2024 | GF-F#-2 | Chrysotile Asbestos<br>10 m <sup>2</sup> | Non-friable | Good Condition | <b>Exterior (ground and level 1):</b><br>Ceiling to the verandah and eaves | 19 October 2013 SLR report:<br>The ceiling to the verandah and eaves - Chrysotile Asbestos fibre detected. Sample GF-F?-2. (Photo 277, 10m2). |

Photo 6 -  
asbestos cement  
sheeting -  
ceiling to the  
verandah and eaves
