## 2024 ASBESTOS REGISTER – GRANT (Building 11), Rockhampton Girls Grammar School

Date of register: 05/08/2024

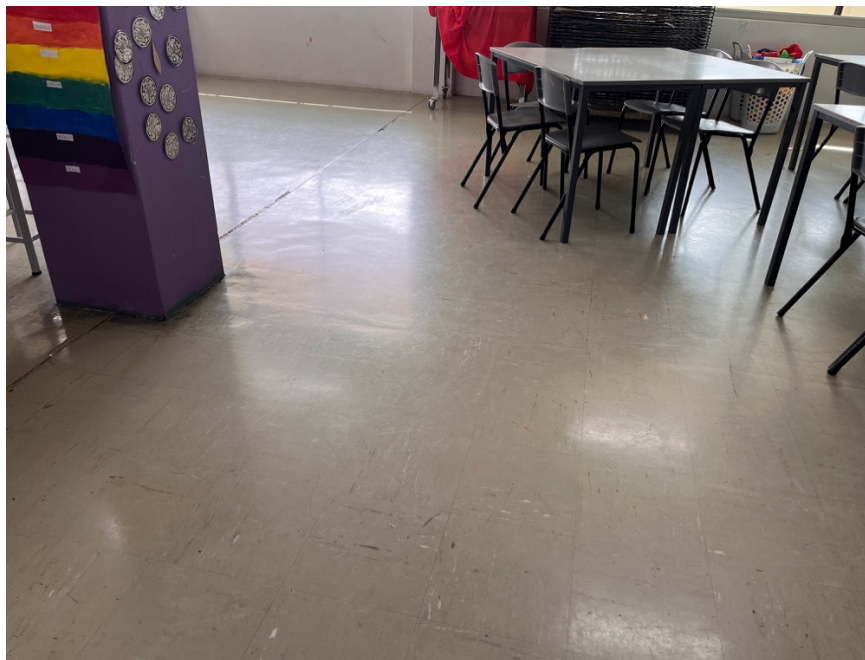
| 05/08/2024 | ENV 001 | Chrysotile >40m <sup>2</sup> | Non-friable unless removed using an abrasive method of removal i.e. lift & grinding concrete | Fair condition with an area of cracked tiles at center of room | Interior:<br>Vinyl floor tiles to the Art room below the G1class room | COHLABS Certificate of Analysis 24-9180<br>Recommend removed during 2025 due to area of poor condition at center of room. | | | | | |

Vinyl tiles containing asbestos

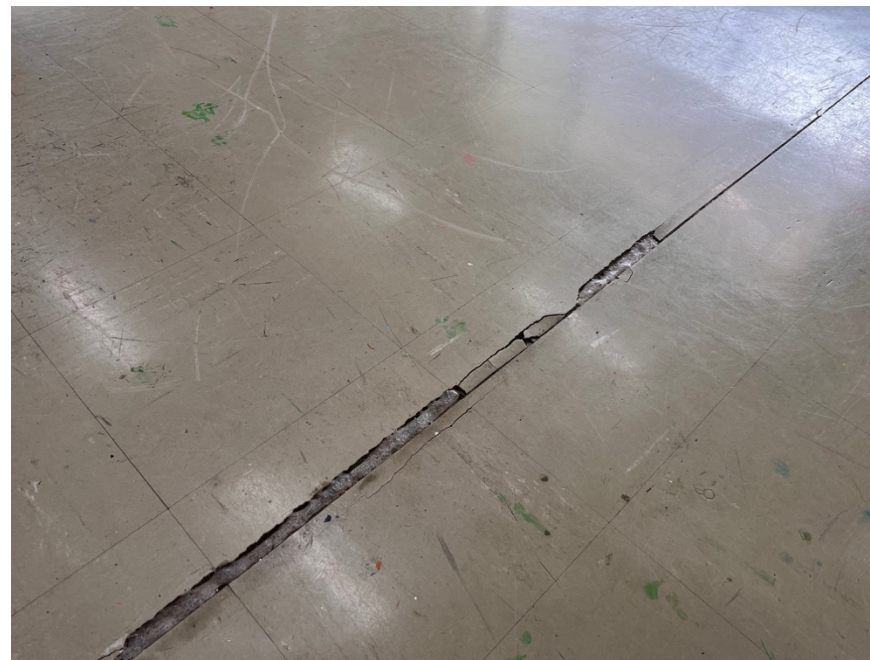
Area were cracking of tiles has occurred

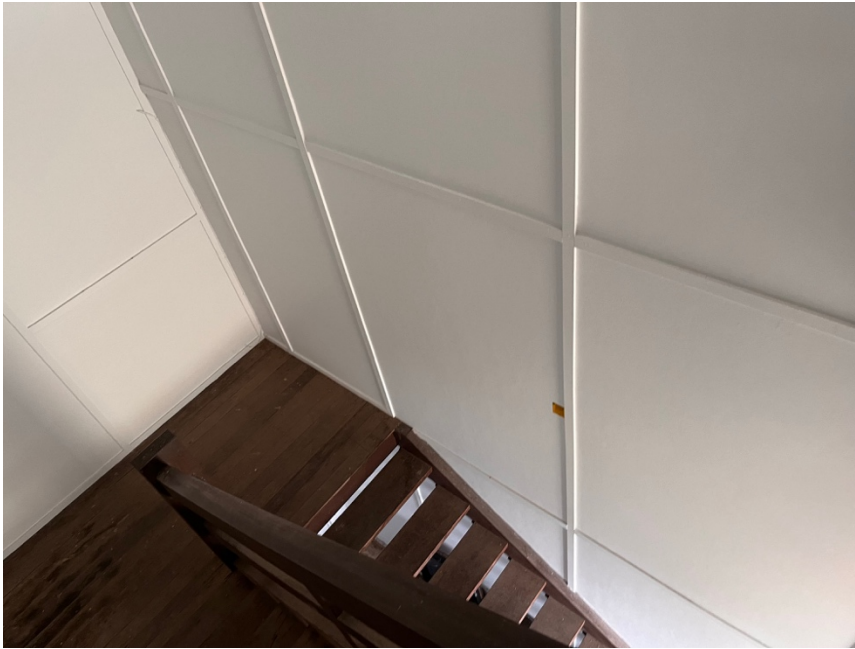
| 05/08/2024 | G5 | Chrysotile >50m <sup>2</sup> | Non-friable | Fair | Internal wall & ceiling sheeting to the fire escape stairwell on the southern side of the building | 19 October 2013 – SLR report:<br>A number of asbestos labels were sighted | | | | | |

Asbestos cement wall sheeting – stairwell southern end of building

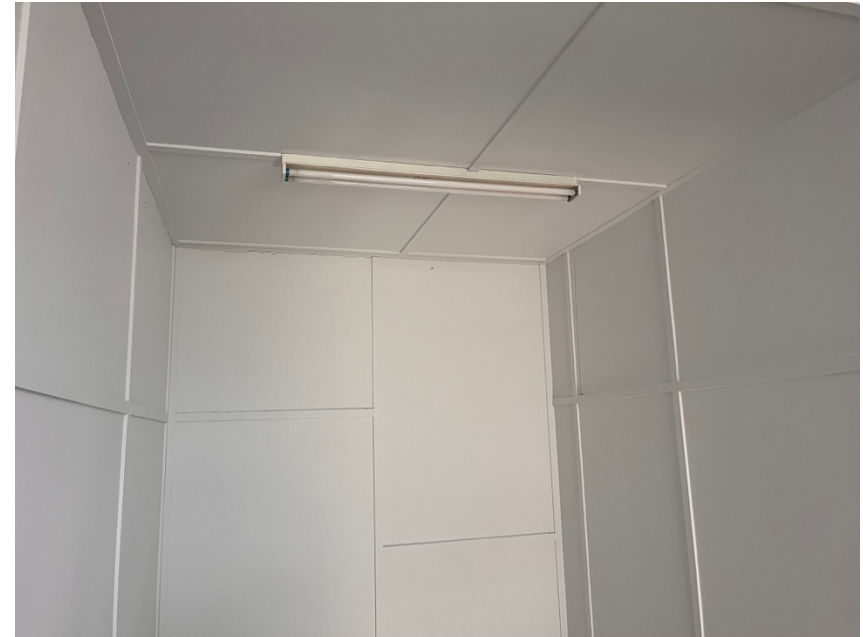
Asbestos cement ceiling sheeting – stairwell southern end of building
