## 2024 ASBESTOS REGISTER – HERITAGE PLAYSHED (Building 17), Rockhampton Girls Grammar School

Date of register: 06/06/2024

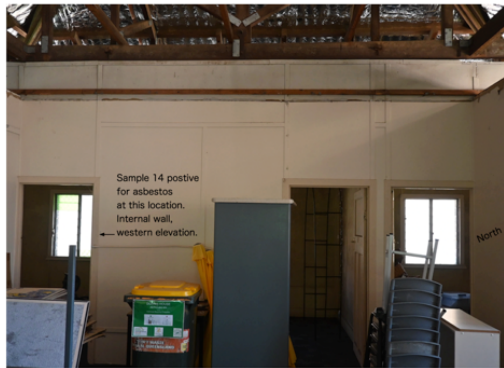
Photo 1 Location of Sample 14

| Date | Sample No. | Type of material identified or assumed and amount<br>(Cross-sectional areas are estimates – measure before quoting) | Friable or non-friable asbestos | Condition of asbestos | Specific location of identified or assumed asbestos | Notes |
|---|---|---|---|---|---|---|
| 10/04/2024 | S14 | Chrysotile<br>12 m <sup>2</sup> | Non-Friable | Fair | <b>Interior:</b><br>Wall of western elevation of main room | Sampled during the 2024 inspections. |

The residual asbestos sheeting is a bonded (non-friable) materials that is painted. The overall risk rating for the building is low.

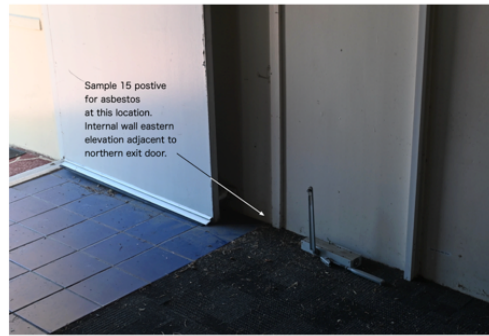
Photo 2 Location of Sample 15

| Date | Sample No. | Type of material identified or assumed and amount<br>(Cross-sectional areas are estimates – measure before quoting) | Friable or non-friable asbestos | Condition of asbestos | Specific location of identified or assumed asbestos | Notes |
|---|---|---|---|---|---|---|
| 10/04/2024 | S15 | Chrysotile<br>12 m <sup>2</sup> | Non-Friable | Fair | <b>Interior:</b><br>Wall adjacent to north entry to building | Sampled during the 2024 inspections. |
