## 2024 ASBESTOS REGISTER – FLORENCE HOUSE, Rockhampton Girls Grammar School

Date of register: 06/06/2024

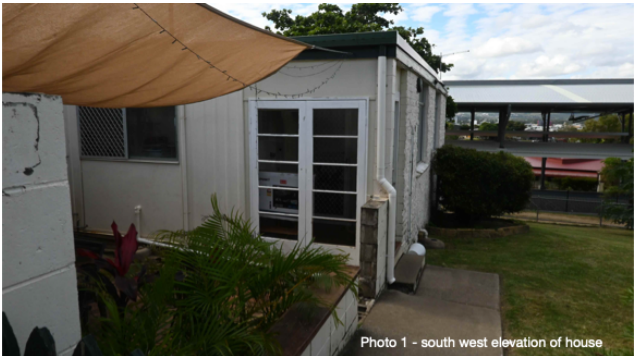
Photo 1 - south west elevation of house

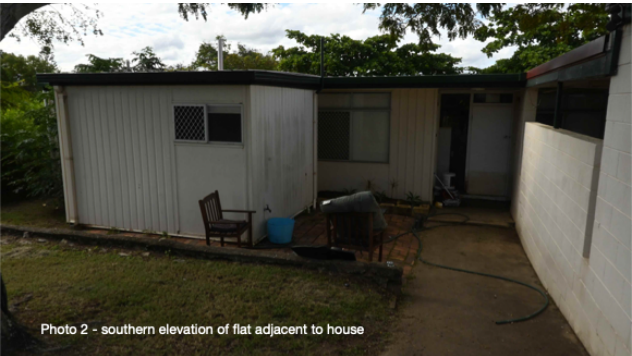
Photo 2 - southern elevation of flat adjacent to house

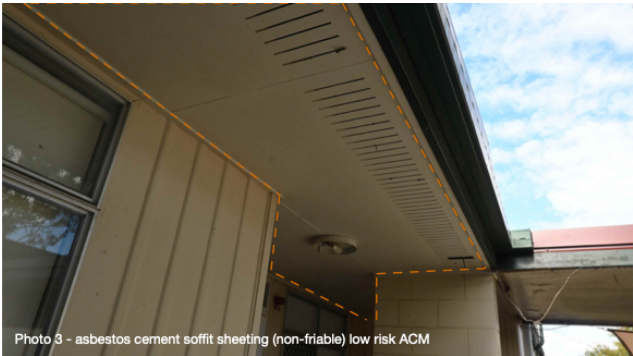
Photo 3 - asbestos cement soffit sheeting (non-friable) low risk ACM

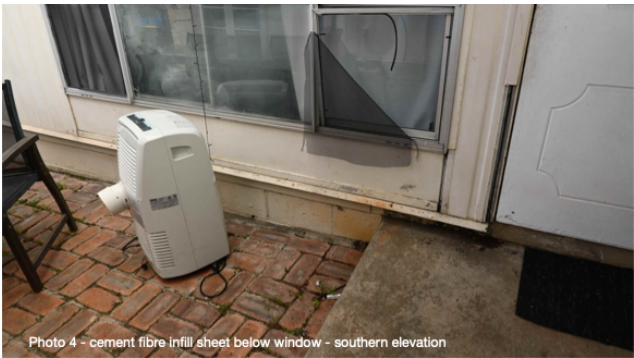
Photo 4 - cement fibre infill sheet below window - southern elevation

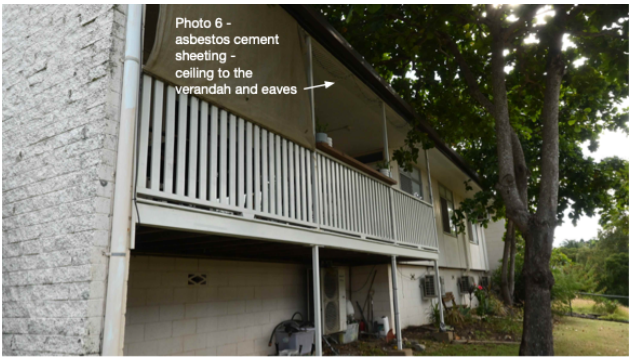
| Date | Sample No. | Type of material identified or assumed and amount<br>(Cross-sectional areas are estimates – measure before quoting) | Friable or non-friable asbestos | Condition of asbestos | Specific location of identified or assumed asbestos | Notes |
|---|---|---|---|---|---|---|
| 06/06/2024 | GF-F#-2 | Chrysotile Asbestos<br>10 m <sup>2</sup> | Non-friable | Good Condition | <b>Exterior (ground and level 1):</b><br>Ceiling to the verandah and eaves | 19 October 2013 SLR report:<br>The ceiling to the verandah and eaves - Chrysotile Asbestos fibre detected. Sample GF-F?-2. (Photo 277, 10m2). |

Photo 6 - asbestos cement sheeting - ceiling to the verandah and eaves

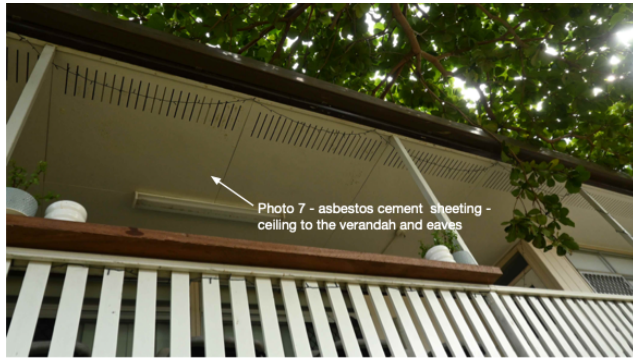
Photo 7 - asbestos cement sheeting - ceiling to the verandah and eaves

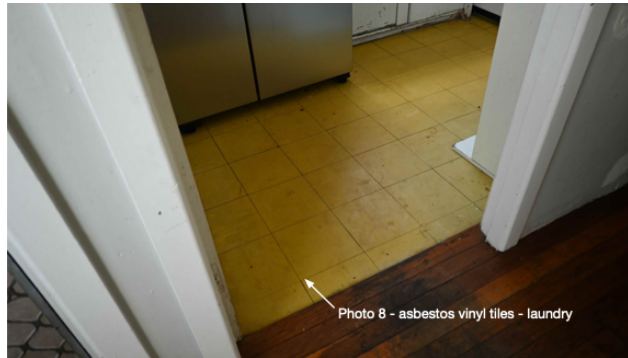
| Date | Sample No. | Type of material identified or assumed and amount<br>(Cross-sectional areas are estimates – measure before quoting) | Friable or non-friable asbestos | Condition of asbestos | Specific location of identified or assumed asbestos | Notes |
|---|---|---|---|---|---|---|
| 06/06/2024 | GF-F1 | Chrysotile Asbestos<br>3 m <sup>2</sup> | Non-friable unless removed using an abrasive method of removal i.e. lift & grinding concrete | Fair condition | <b>Interior:</b><br>Vinyl tiles to the Laundry floor | 19 October 2013 SLR report:<br>Vinyl tiles to the Laundry floor – Chrysotile Asbestos fibre detected. |

Photo 8 - asbestos vinyl tiles - laundry

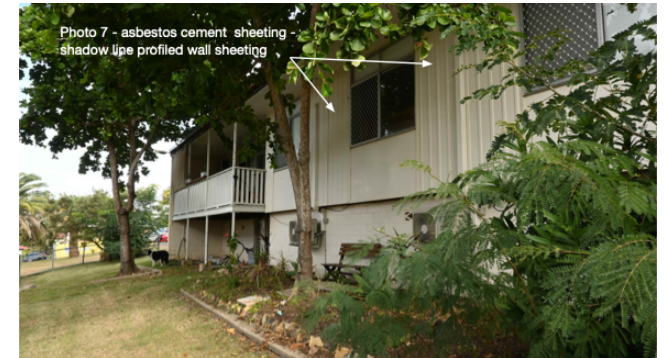
| Date | Sample No. | Type of material identified or assumed and amount<br>(Cross-sectional areas are estimates – measure before quoting) | Friable or non-friable asbestos | Condition of asbestos | Specific location of identified or assumed asbestos | Notes |
|---|---|---|---|---|---|---|
| 06/06/2024 | GF-F5 | Chrysotile Asbestos<br>> 5 m <sup>2</sup> | Non-friable | Good condition | <b>Exterior (ground level):</b><br>Shadow line profiled wall sheeting of the residence (elevation 1) | 19 October 2013 SLR report:<br>The Shadow line profiled wall sheeting to the external of the Residence - Chrysotile Asbestos fibre detected. |
| 06/06/2024 | GF-F6 | Chrysotile Asbestos<br>> 5 m <sup>2</sup> | Non-friable | Good condition | <b>Exterior (ground level):</b><br>Shadow line profiled wall sheeting of the residence (elevation 2) | 19 October 2013 SLR report:<br>The Shadow line profiled wall sheeting to the external of the Residential Flat - Chrysotile Asbestos fibre detected. |

Photo 7 - asbestos cement sheeting - shadow line profiled wall sheeting
