RGGS Stage 2 - Site logs

Rockhampton Girls Grammar School  
Cnr Denham and Agnes Street - The Range, Rockhampton, Qld, 4700

## Site- logs RGGS, Stage 2

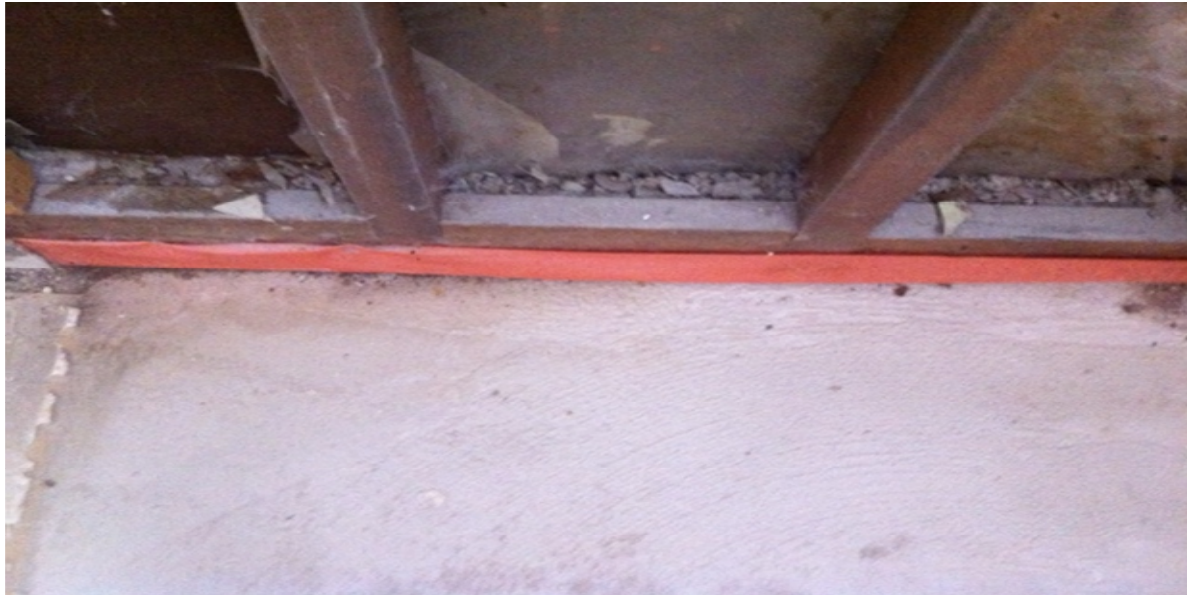
- 1) Assumed asbestos debris has been located in the south and east wall cavities (in the bottom plate and on top of noggin areas). Please note this debris was discovered today at 0930. Yesterday afternoon Woollam Construction workers deconstructed the fibreglass Shower cubicles. This debris was found behind where the showers were originally positioned. **Please refer to photos 1 and 2.**
- 2) The ceiling lining in the northern shower/ablution room is "double lined". The original asbestos ceiling runs across the top of another fibre cement (also assumed asbestos) ceiling in the Shower/ablution Room. **Please refer to Photo 3** that shows the double lined ceiling.
- 3) Possibility that bulkheads may be lined with asbestos (behind the original lining). **Please refer to photo 4**

**Photo 1-** Shows Assumed debris on along south wall bottom plate. (triangular shaped pieces are what are assumed)

No removal in these areas until Laboratory results is received.

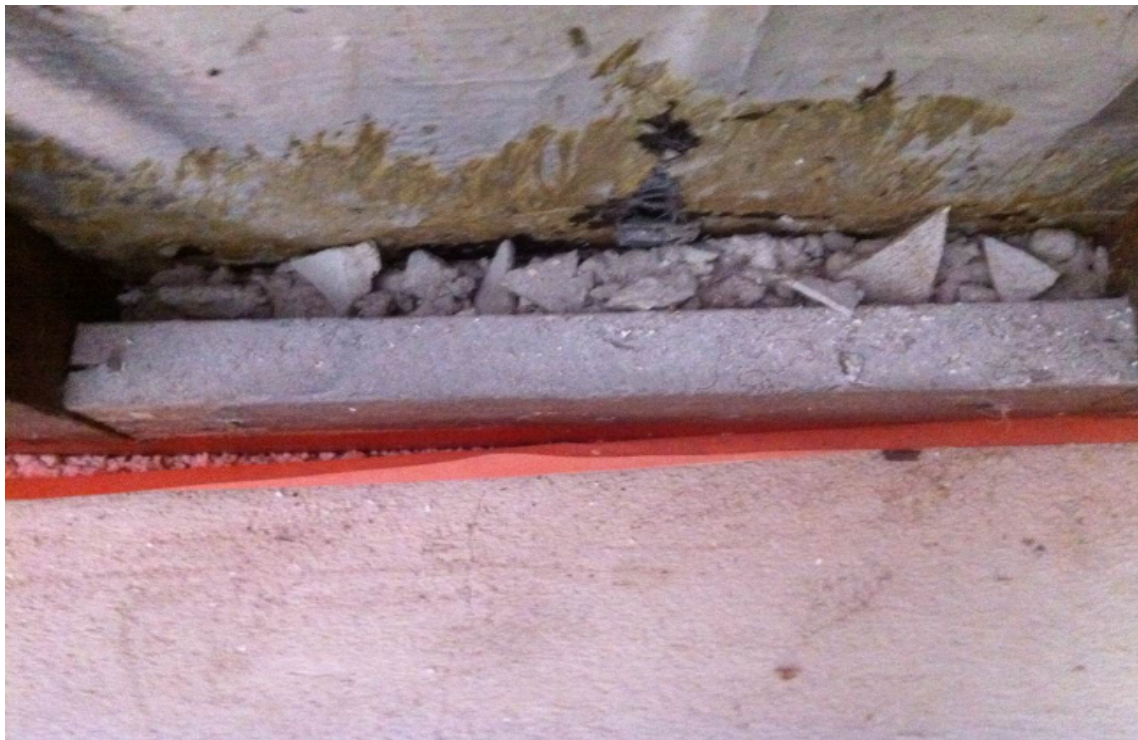
**Photo 2** – shows assumed asbestos debris on east wall bottom plate (triangular shape pieces are what is assumed to be asbestos)

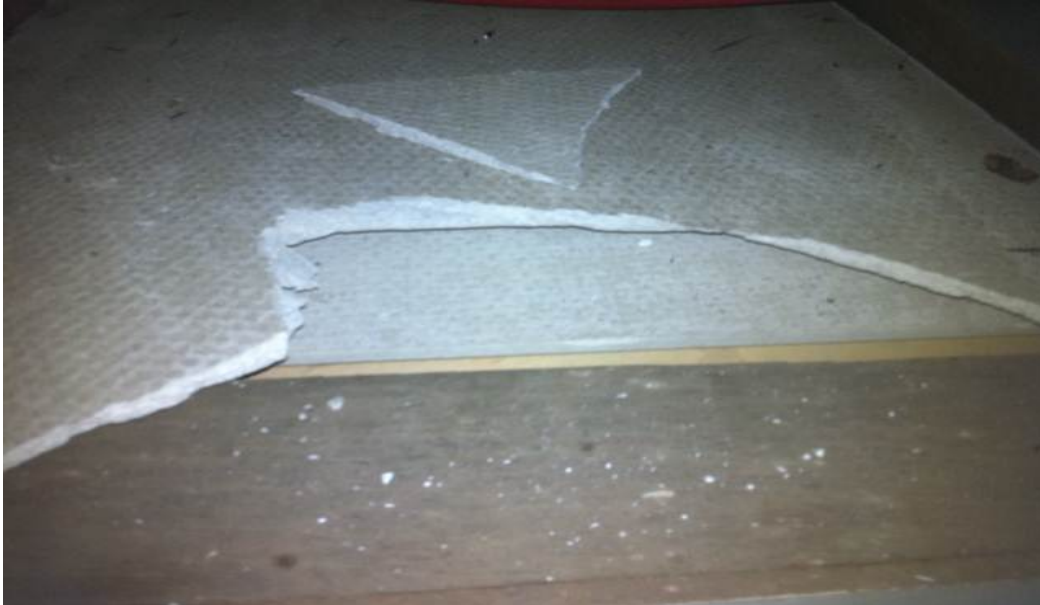
**Photo 3** – shows double lined ceiling (both assumed to contain asbestos) in the northern end 1<sup>st</sup> Floor shower/ablution Room on the 1<sup>st</sup> floor of Luck House.

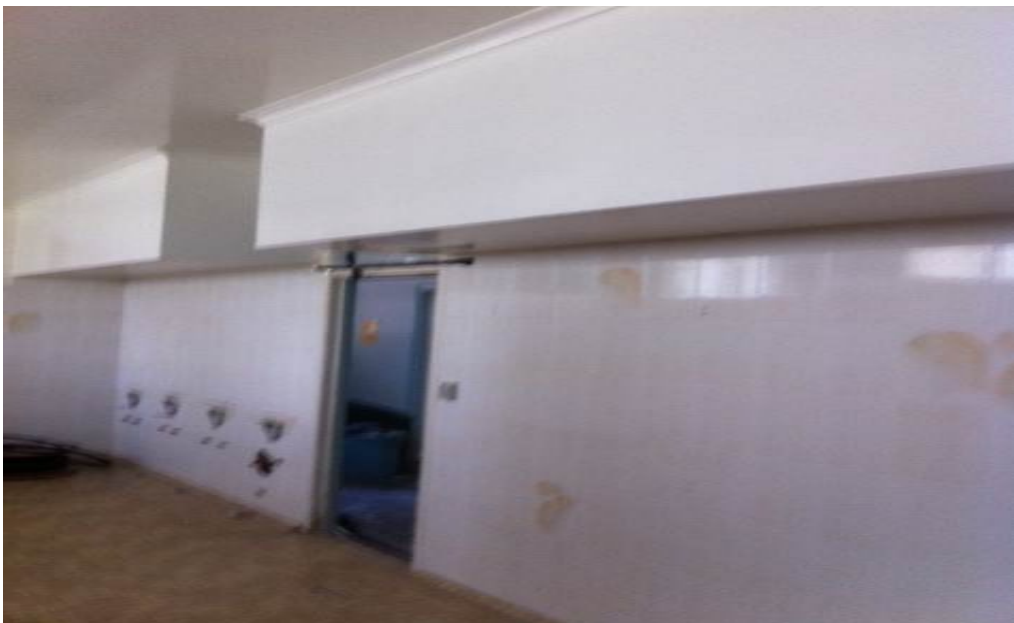
**Photo 4** – Photo shows south to north running bulkheads, these bulkheads may be lined with asbestos. No photographic evidence can be supplied at this stage at this stage. Only when the asbestos ceiling is removed in this room can we visualise if the bulkheads internal face is assumed to be asbestos.

Whilst the walls in this 1<sup>st</sup> floor Bathroom/ablutions were classed as non-asbestos we do not recommend that Woollams remove these walls as they could be exposed asbestos debris in the wall cavity.

Please note: slight possibility that bulkheads that run north to south along the western wall in the northern Bathroom may also be lined with asbestos (yet to determine)
