29 November 2012

624.10202 20121129

Rockhampton Girls Grammar School  
Cnr Denham and Agnes Street  
Rockhampton, QLD, 4700

Further "Assumed" asbestos was found in the following locations of the first floor northern end Showers/Ablution Room of Luck House. Areas as follows;

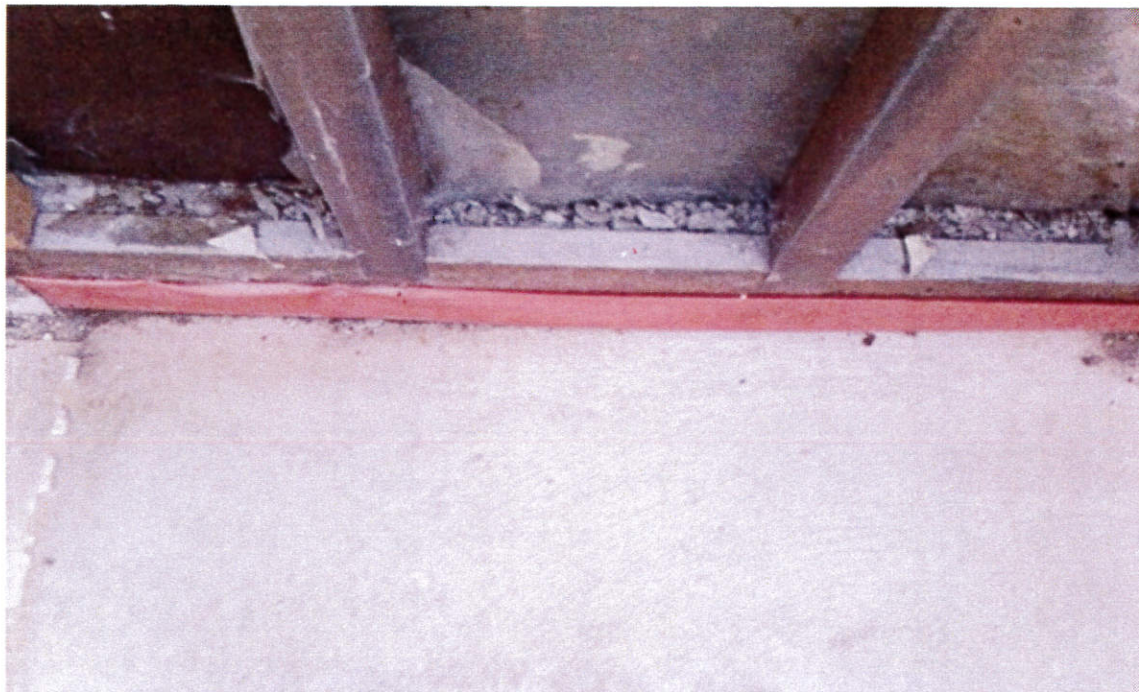
**Photo 1-** Shows Assumed debris on along south wall bottom plate. (triangular shaped pieces are what are assumed)

Recommendations: Allow Licenced asbestos removalist to remove all new assumed walls and ceilings in this room.

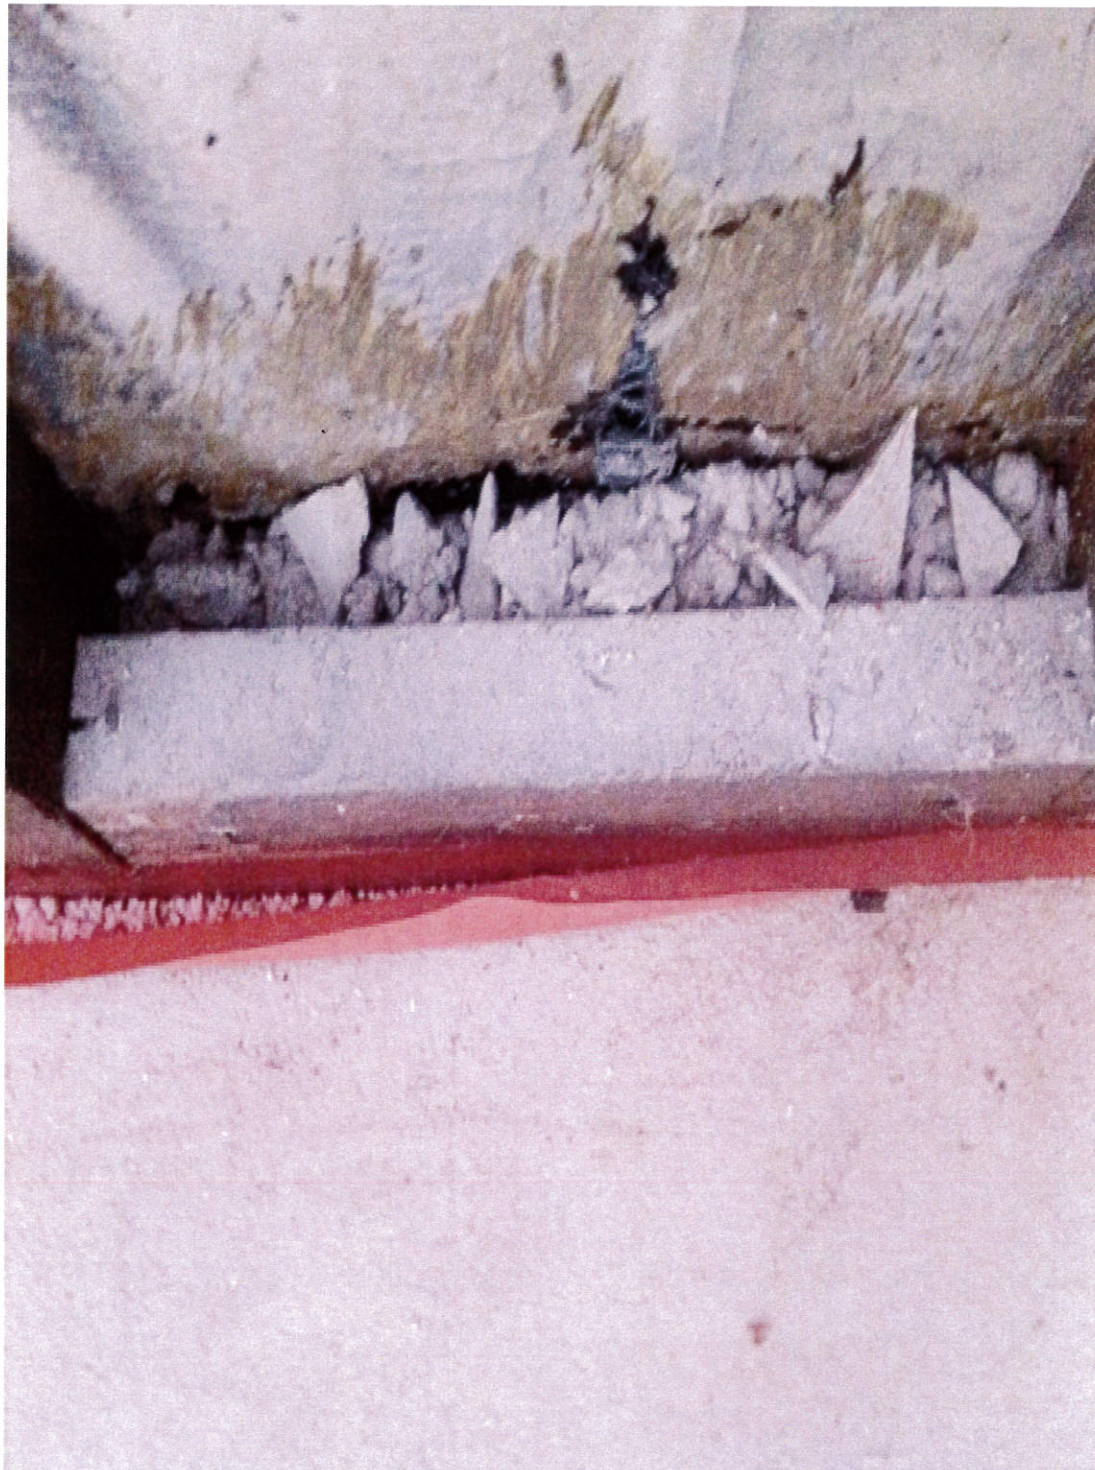
**Photo 2** – shows assumed asbestos debris on east wall bottom plate (triangular shape pieces are what is assumed to be asbestos)

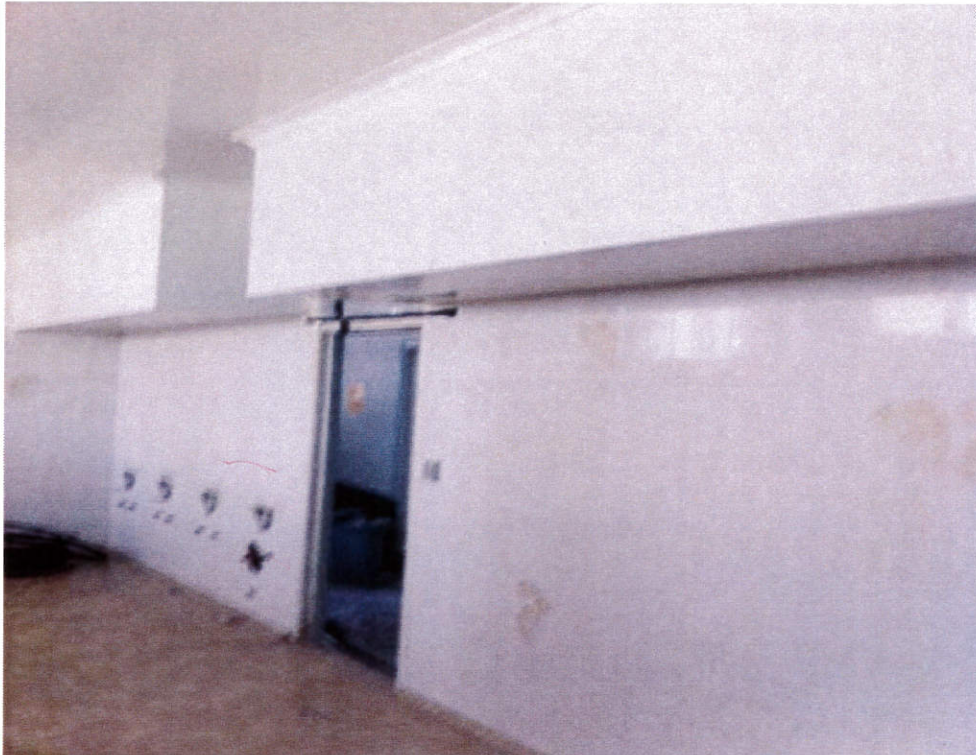
**Photo 4** – Photo shows south to north running bulkheads, these bulkheads may be lined with asbestos. No photographic evidence can be supplied at this stage at this stage. Only when the asbestos ceiling is removed in this room can we visualise if the bulkheads internal face is assumed to be asbestos.

Whilst the walls in this 1<sup>st</sup> floor Bathroom/ablutions were classed as non-asbestos we do not recommend that Woollams remove these walls as they could be exposed asbestos debris in the wall cavity.

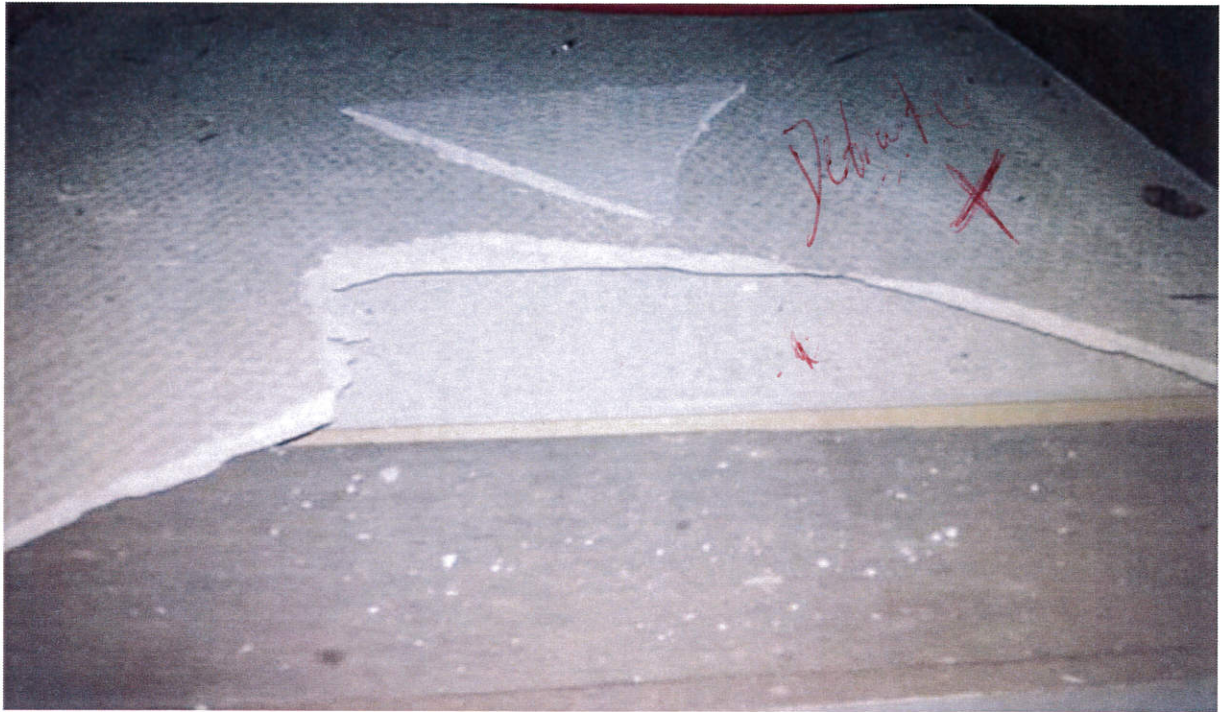
**Photo 3** – shows double lined ceiling (both assumed to contain asbestos) in the northern end 1<sup>st</sup> Floor shower/ablution Room on the 1<sup>st</sup> floor of Luck House.

Recommendations: Allow Licenced asbestos removalist to remove all new assumed walls and ceilings in this room.

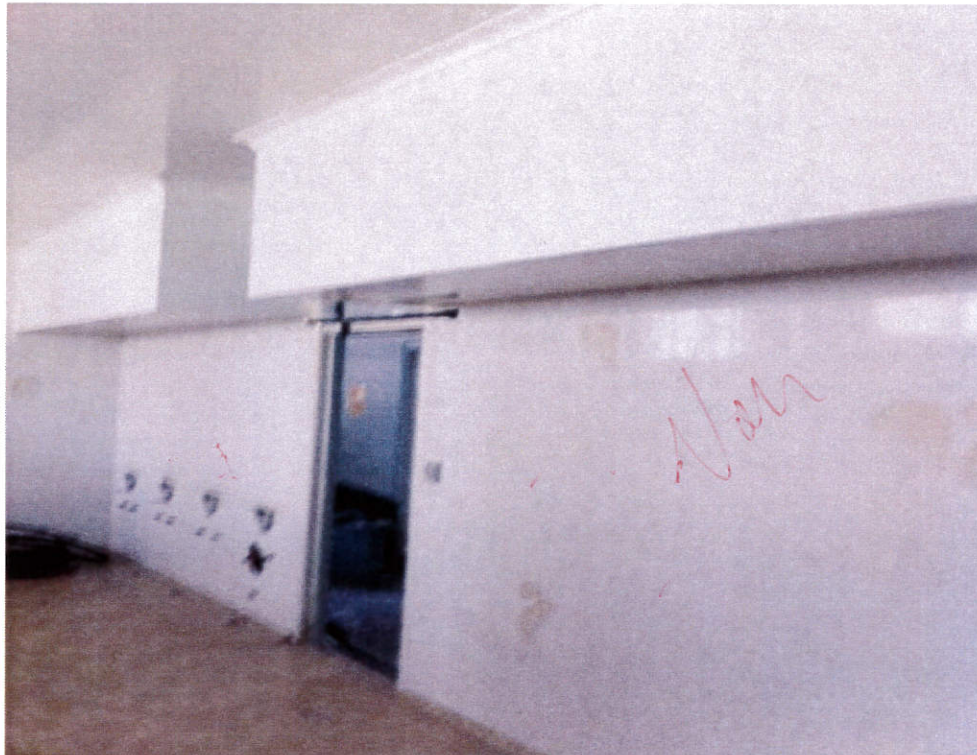
**Photo 4** – Photo shows south to north running bulkheads, these bulkheads may be lined with asbestos. No photographic evidence can be supplied at this stage at this stage. Only when the asbestos ceiling is removed in this room can we visualise if the bulkheads internal face is assumed to be asbestos.

Whilst the walls in this 1<sup>st</sup> floor Bathroom/ablutions were classed as non-asbestos we do not recommend that Woollams remove these walls as they could be exposed asbestos debris in the wall cavity.
