Rockhampton Girls  
Grammar School  
Est 1892

## 2024 Asbestos Management Plan and Asbestos-Containing Materials Register:

**File Name:** ENV-2023-062 Ver 1-4 Asbestos Management Plan & ACM Register – RGGS, Denham St The Range Q 4700.pdf

## Rockhampton Girls Grammar School

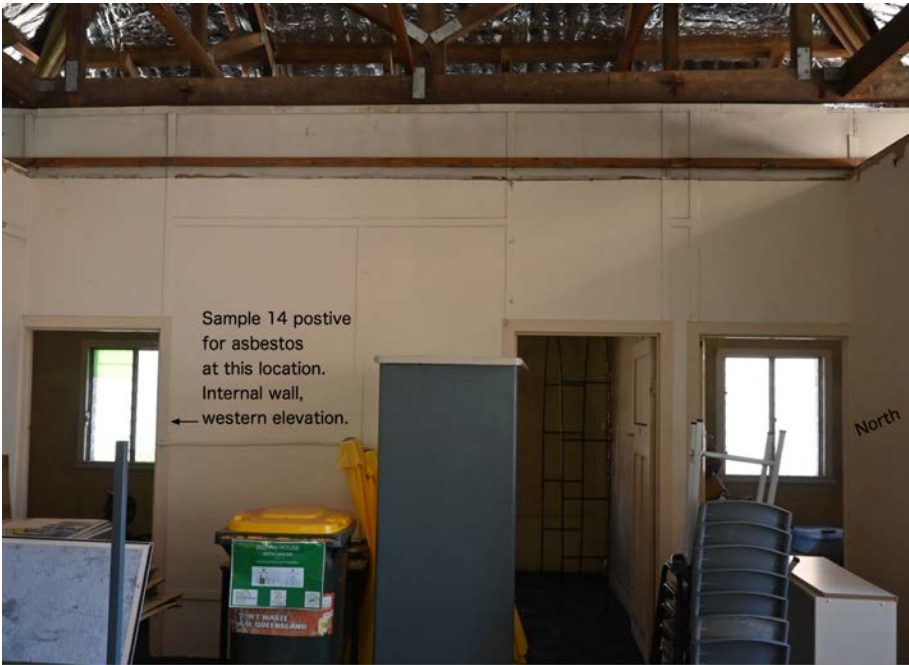
| Lab ID | Sample ID | Sample Details | Sample Type | Size / Weight<br>cm/g | Asbestos<br>Present | Fibres<br>Identified |
|---|---|---|---|---|---|---|
| 011 | S14 | Heritage playsh central room - Ground internal wall - Wall western end of room | Fibre Cement | 2 x 1.5 | Yes | CHR, ORF |

Photo 1 Location of Sample 14

The residual asbestos sheeting is a bonded (non-friable) materials that is painted. The overall risk rating for the building is low.

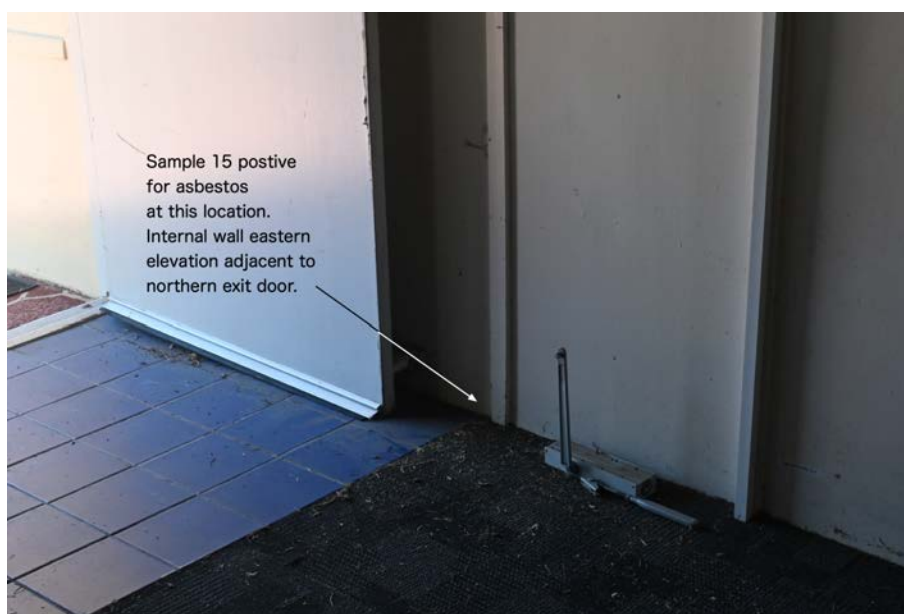
| Lab ID | Sample ID | Sample Details | Sample Type | Size / Weight<br>cm/g | Asbestos<br>Present | Fibres<br>Identified |
|---|---|---|---|---|---|---|
| 012 | S15 | Heritage playsh central room - Ground internal wall - Wall adjacent north entry | Fibre Cement | 1 x 1 | Yes | CHR |

Photo 2 Location of Sample 15

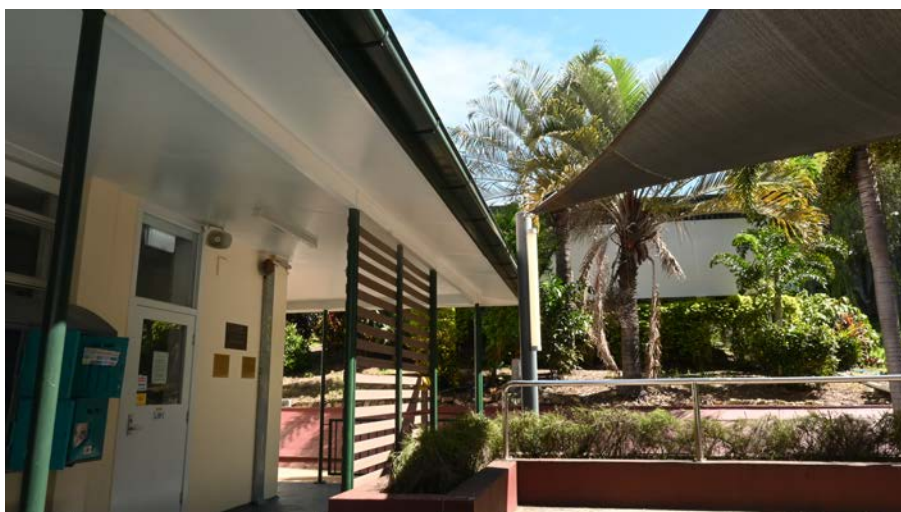
- External ceilings sheets to the covered area off the library;
- Slotted eaves, ground level;
- Wall sheeting to fire hose cabinets adjacent to bathrooms, level 1 & 2
- Wall sheeting to hot water cabinet in bathroom, level 1;
- Wall sheeting to student and supervisor's shower rooms, toilets & behind tiles, levels 1 & 2; and
- Wall sheeting to hot water cabinet in bathroom, level 2.

**Photograph 1 Modern renovations of external ground floor areas of Jackson House**

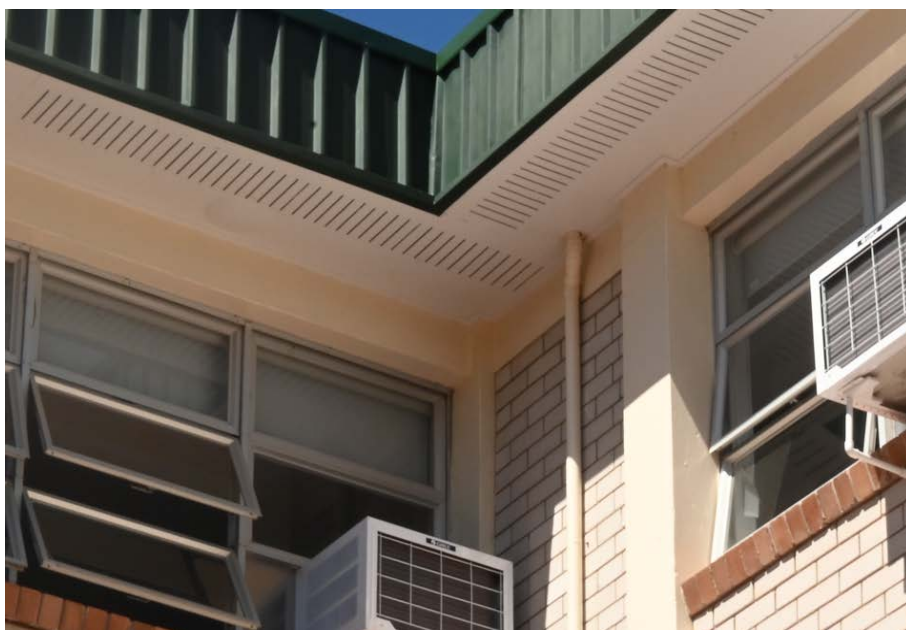
**Photograph 2 Jackson House, soffits - tentatively assessed as bonded (non-friable) asbestos**

In addition, the Assessor found that the soffits on level one and two of Jackson House appear to be slotted asbestos-cement sheeting.

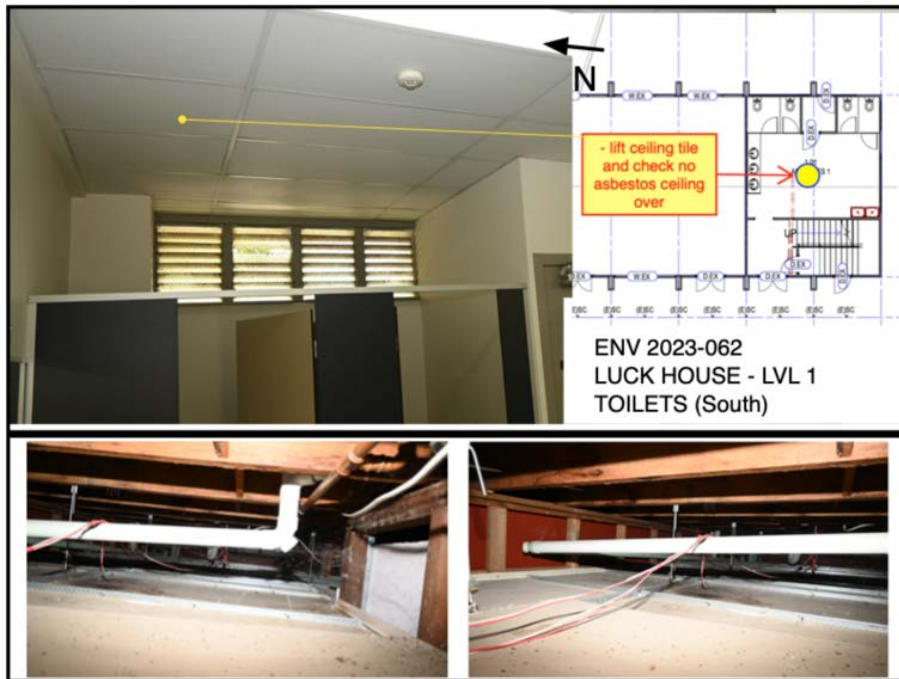
Based on a thorough visual inspection, there is no sign of asbestos-cement sheeting above the plaster ceiling tiles in the toilet area at the southern end of the ground floor (level one) of Luck House. To reaffirm this finding, please review the provided photograph depicting the condition of the ceiling tiles both below and within the surrounding ceiling space.

Photograph 3 Inspection of ceiling voids of Luck House

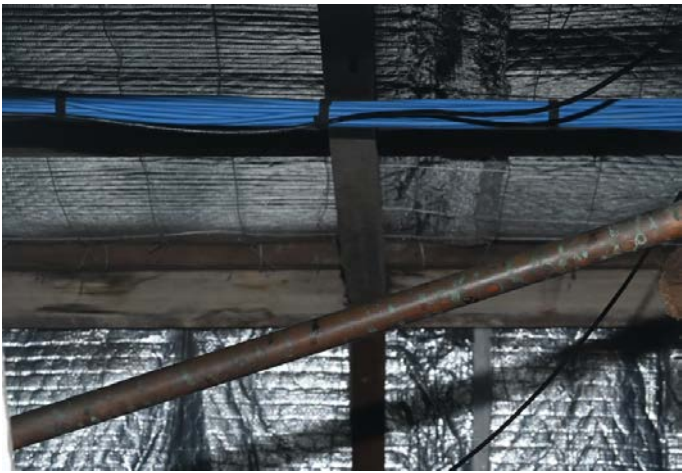
Where possible ceiling spaces were inspected. The inspection found the ceiling voids to be clean. There is no visual evidence of suspect materials.

**Photograph 4 Inspection of ceiling voids of Paterson House**

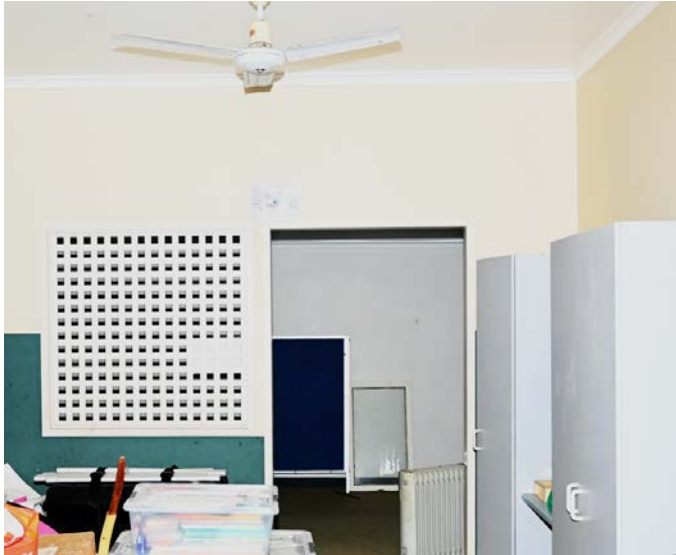
Additionally, the inspection verified that asbestos-containing plant and equipment, previously housed in plant rooms and the ground floor kitchen, have all been removed between 2010 and 2024.

Photograph 5 Renovated office and storage areas on level one of Paterson House

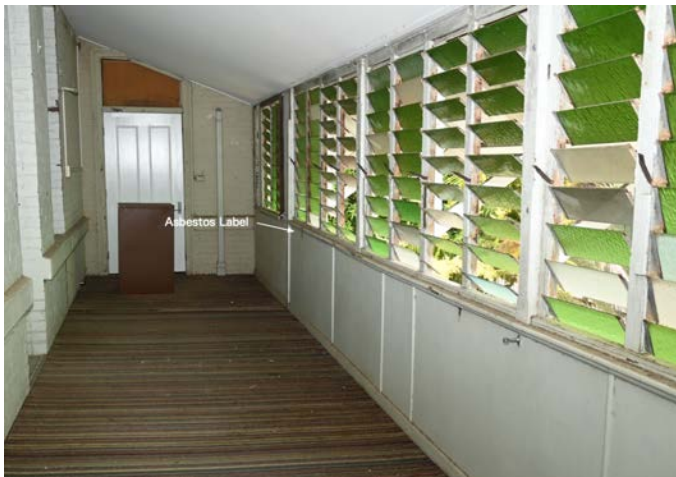
On the eastern elevation of the first level, the assessor identified bonded (non-friable) asbestos cement wall sheeting. It is important to note that bonded asbestos is typically considered to pose a low risk of exposure, as it is tightly bound within the cement matrix and is less likely to release fibers into the air when left undisturbed. Properly managed and maintained, bonded asbestos materials can safely remain in place without significant health hazards. However, any disturbance during renovation or demolition activities should be carried out by licensed professionals to ensure safety.

Photograph 6 A/C Wall Sheeting - Level 1 Eastern Elevation of Paterson House

The image above depicts an asbestos label frequently seen on wall sheeting on the eastern elevation of level one. The asbestos wall sheeting, noted for its fair condition despite paint fading and discolouring. Access to the area is restricted by a locked door.

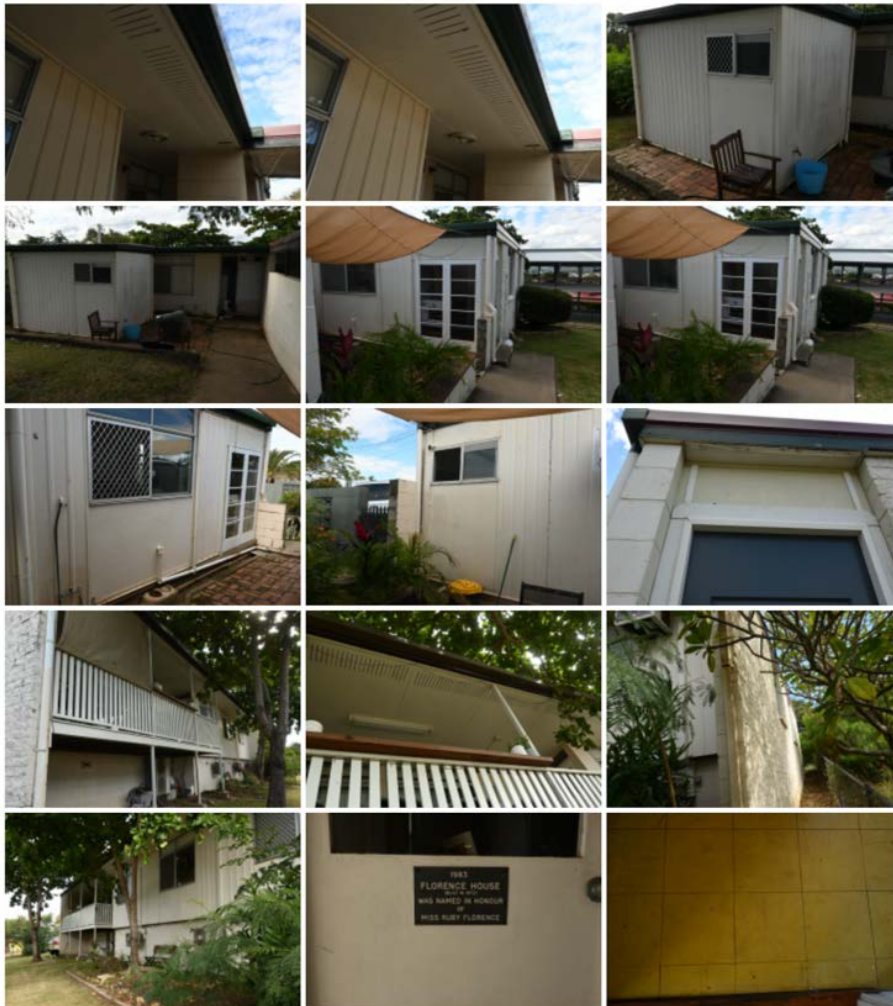
The 2024 inspection identified residual asbestos-containing materials (ACMs), as depicted in the photograph below, which shows asbestos cement sheeting and floor tiles found in the laundry.

Photograph 7 Asbestos Cement Sheeting and Asbestos Tiles - Florence House

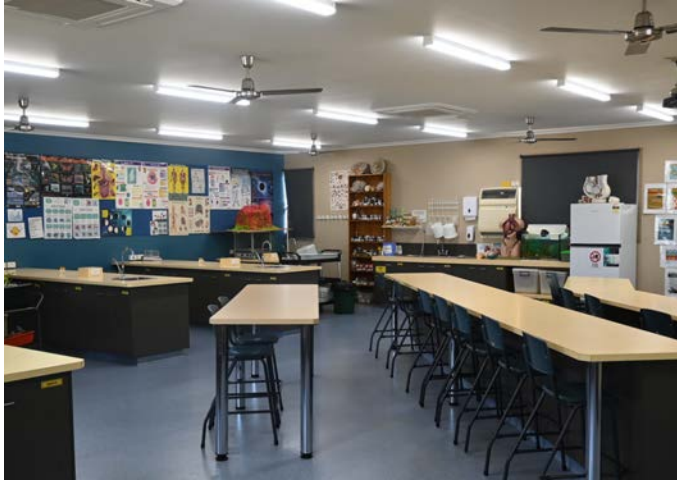
The 2024 inspection revealed a substantial amount of asbestos has been removed and replaced with modern materials as illustrated by the below photograph.

Photograph 8 Junior Science Laboratory - Modern Renovations

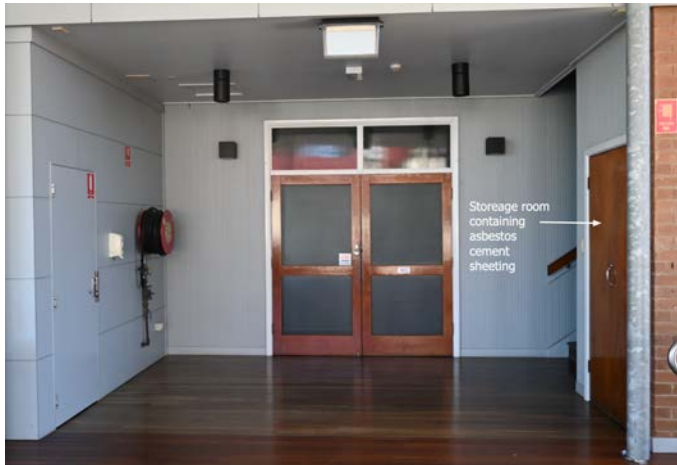
Wall and ceiling sheeting to the storage cupboard located below the stairwell at the entry to the hall and tentatively the soffits indicated by the presence of the original air vents.

Photograph 9 Location of ACMs within McKeague Hall storage room

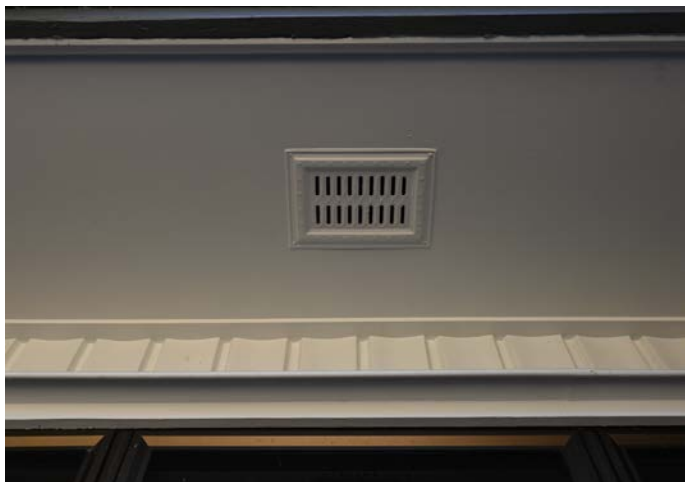
Photograph 10 Suspect material surrounding air vent of soffits

Please be aware that a sample of the soffits of Luck House that has the same air vents tested positive for asbestos.

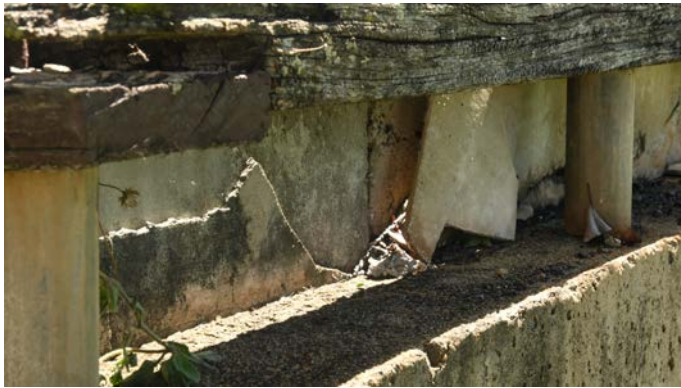
RGGGS Maintenance requested sample to be taken. Sample taken and result was no asbestos detected.

Photo 3 Form-work - Main Car Park

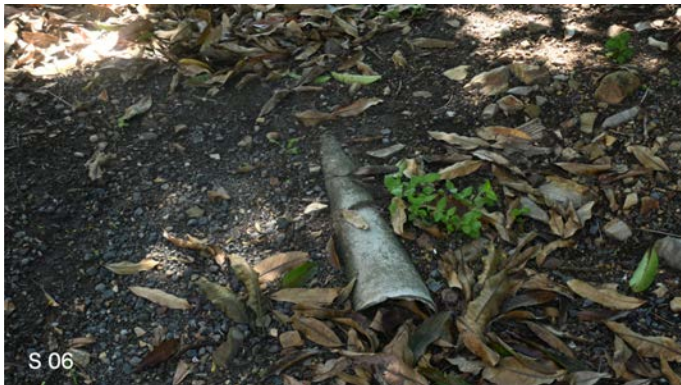
Photo 4 Exposed Pipe - Tested Positive for Asbestos

A concrete pipe of about 100mm diameter and 2m length that disappears underground towards the landscaped area of CAB was tested and found to contain asbestos.
