## Asbestos Management Plan for Rockhampton Girls Grammar School Facilities 2024

**Version 1.1 – 26/07/2024**

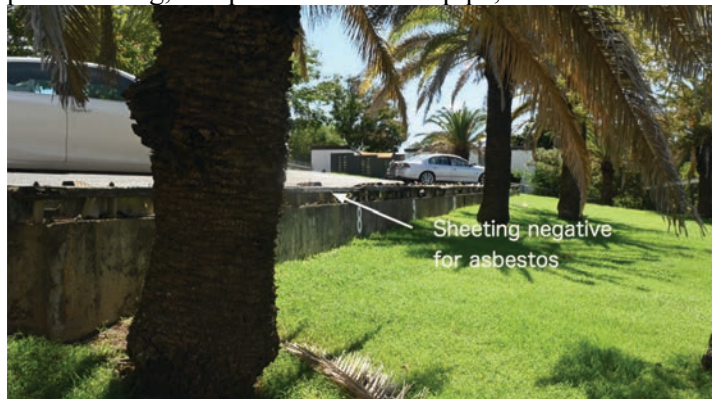
Figure 1 - Sample S05 (12/04/2024) negative for asbestos

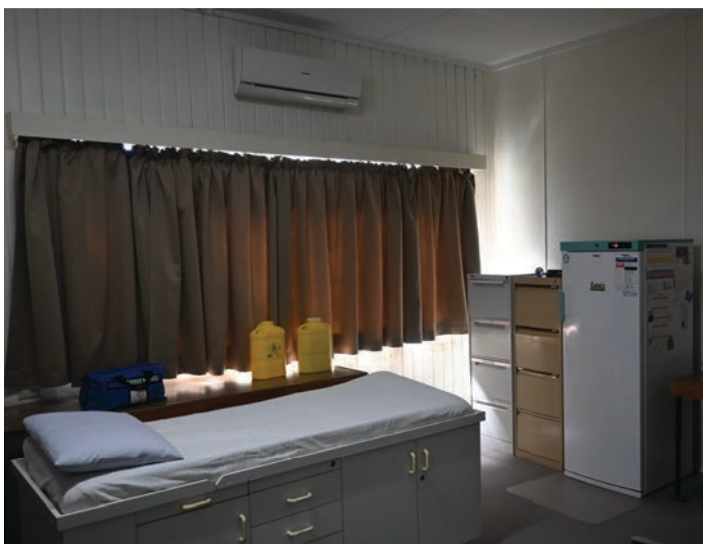
The 2024 inspection revealed that several of the items listed in the 2010 asbestos register were still present. Fortunately, these materials were found to be well-painted and in excellent condition.

*Photograph 5 Health Care Centre*

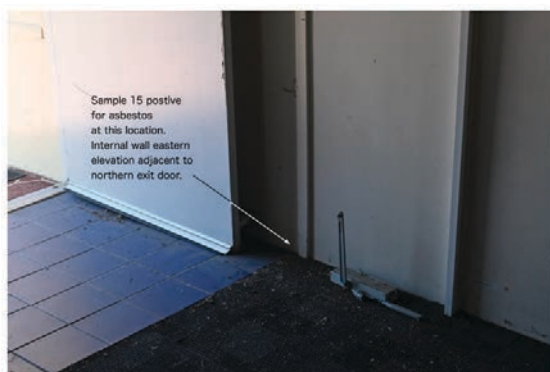
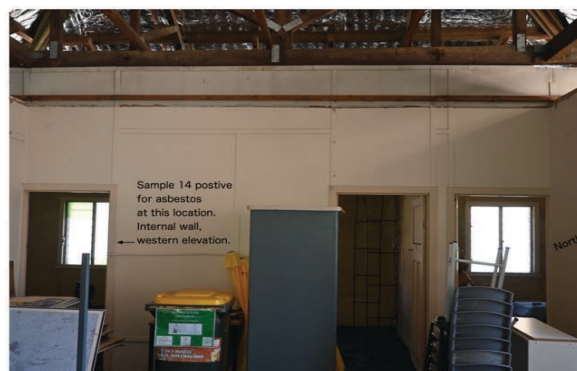
| <b>Recommendations:</b> | | Masonite identified in most areas, however some walls may still contain asbestos. | | | | |

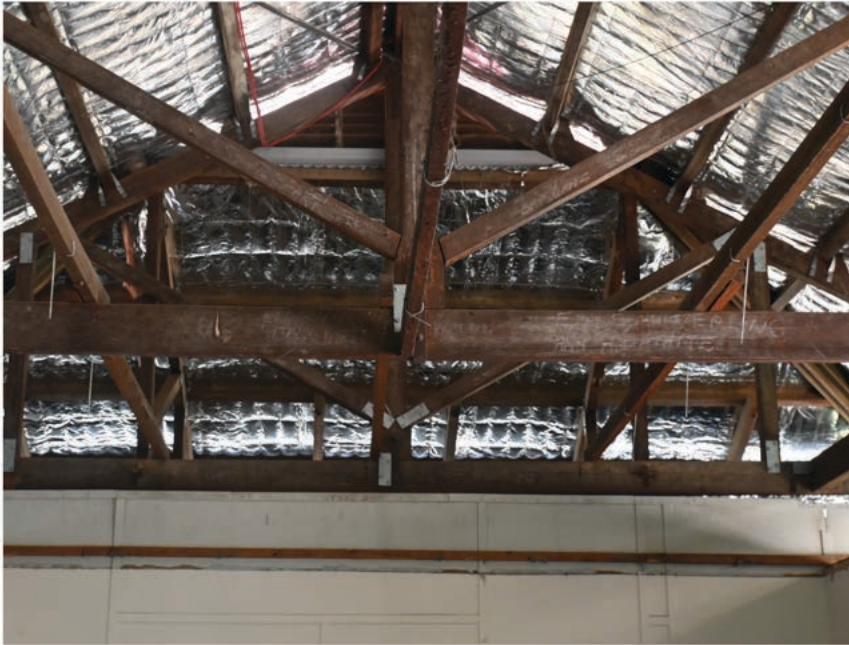
There is visual evidence of substantial removal of asbestos-cement sheeting, in particular the ceiling space of the Heritage Playshed as illustrated by the following photographs:

*Photograph 6 Heritage Playshed Eastern Elevation Ceiling*

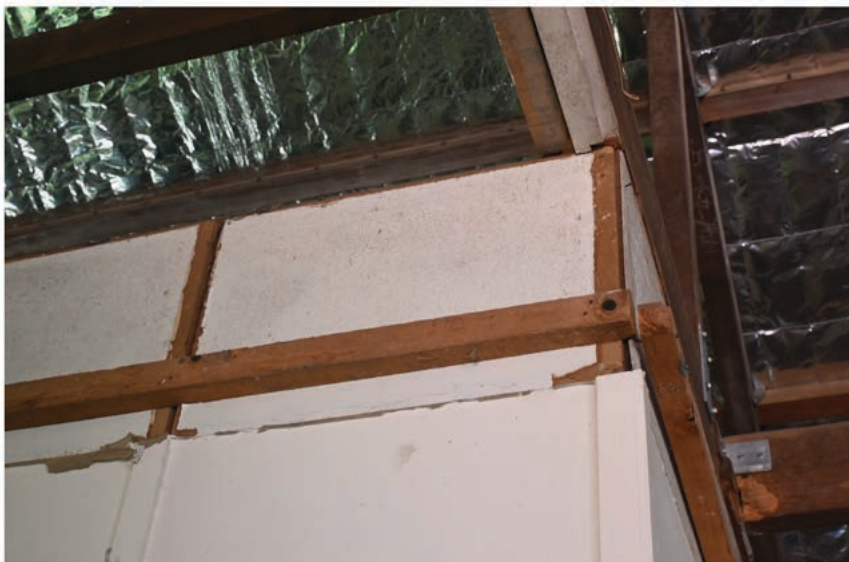
*Photograph 7 Panels and infill panels removed at various locations*

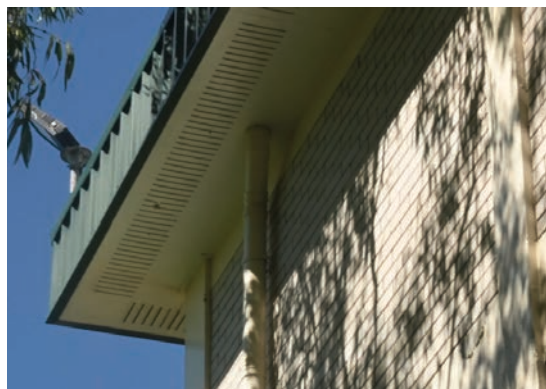
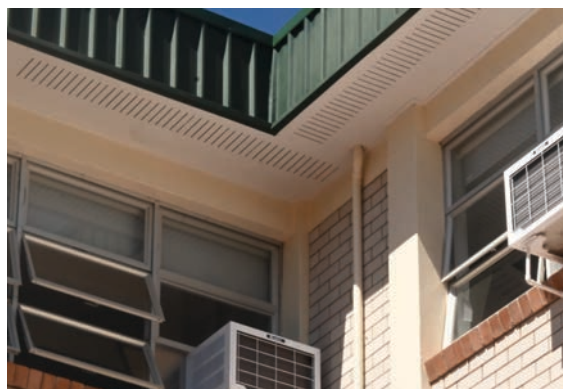
| <b>Condition:</b> | Good | <b>Class:</b> | Bonded (non-friable) asbestos |
| <b>Quantity:</b> | More than 50m2 | <b>Type:</b> | Chrysotile (white asbestos) |

| <b>Recommendations:</b> | Maintain with paint until removed under B-class controls and replacement with modern materials. | | |

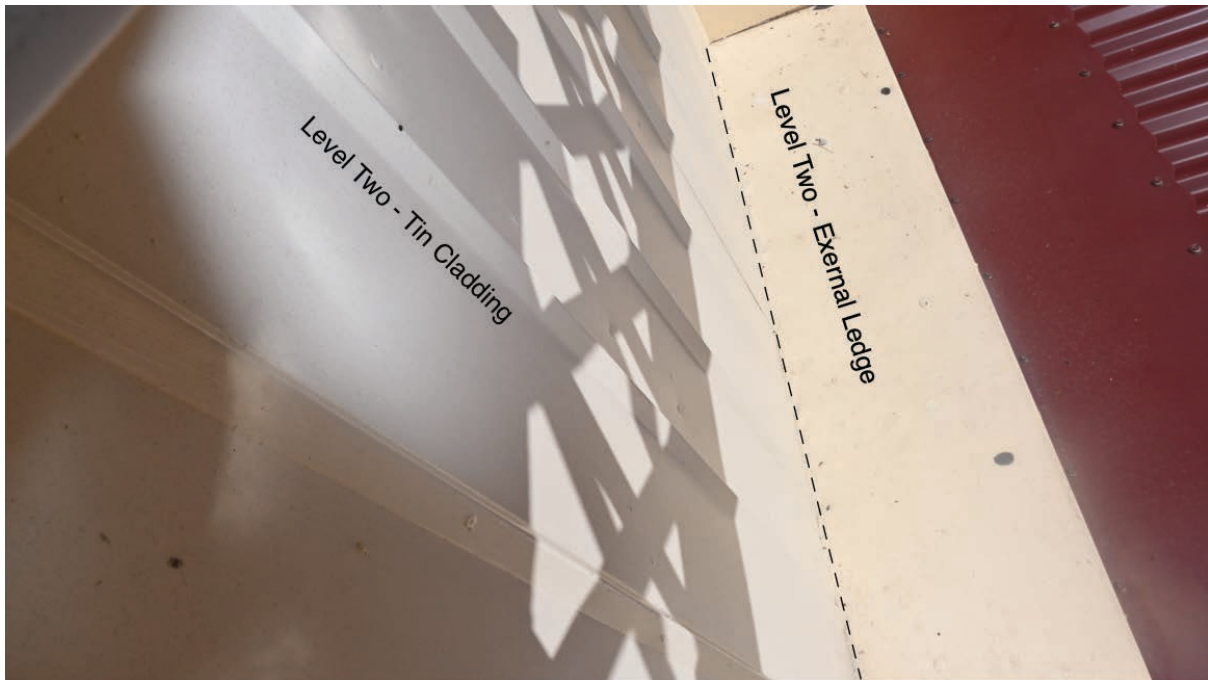
The 2024 inspection also identified that the external cladding may conceal cement sheeting, however destructive sampling and an elevated work platform.

The 2024 inspection of Luck House revealed that the building now contains modern materials, thanks to extensive renovations completed between 2010 and 2024.

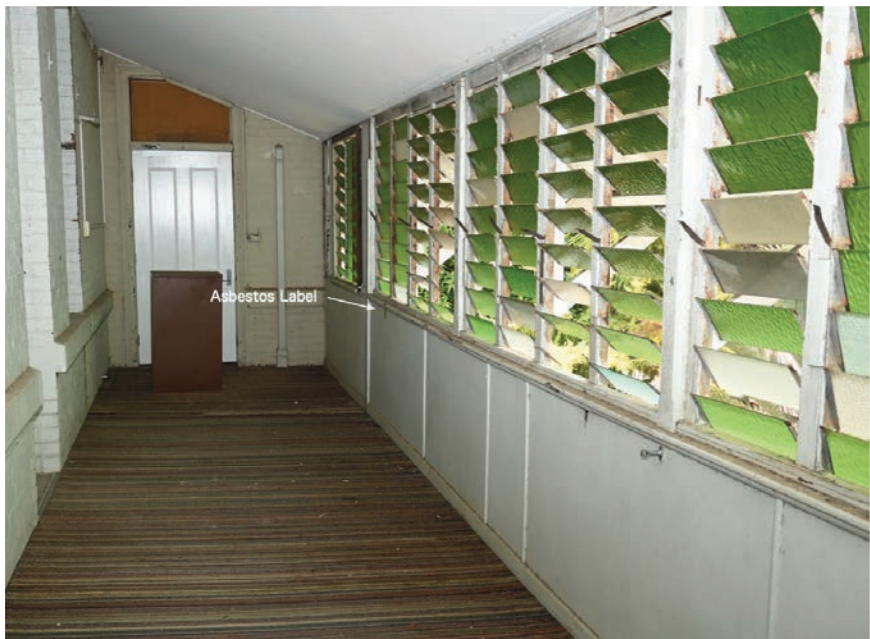
| <b>Condition:</b> | Fair | | <b>Class:</b> | Bonded |
| <b>Quantity:</b> | More than 10m2 | | <b>Type:</b> | Chrysotile |

| <b>Recommendations:</b> | Always sample sheeting that has not been confirmed to be of modern materials. Restrict access to the veranda on level 1, western elevation until removal has occurred. | | | |

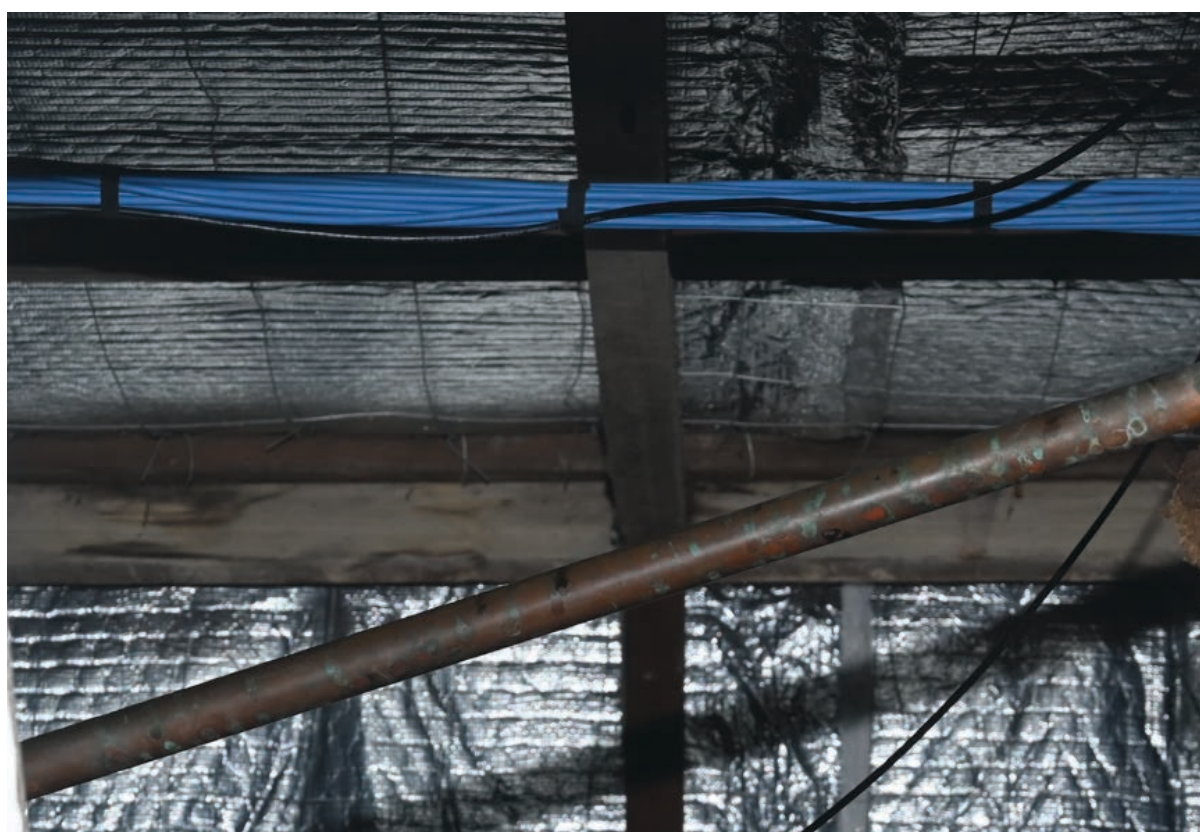
Where possible ceiling spaces were inspected. The inspection found the ceiling voids to be clean. There is no visual evidence of suspect materials.

*Photograph 9 Inspection of ceiling voids Paterson House*

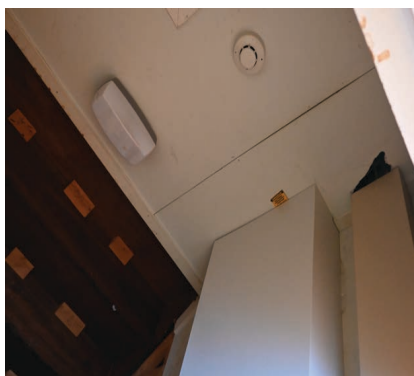
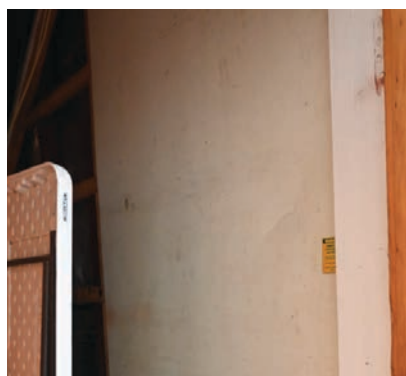
| <b>Sample Number:</b> | <b>2010</b> | <b>Location:</b> | Southern elevation, ground floor under stairs within locked storage room. | |
| <b>Condition:</b> | Fair | | <b>Class:</b> | Bonded (non-friable) |
| <b>Quantity:</b> | Less than 5 m2 | | <b>Type:</b> | Chrysotile<br>Amosite<br>Crocidolite |
| <b>Photographs:</b><br><br>Left – ceiling sheet<br>Right – wall sheet | | | | |

| <b>Recommendations:</b> | Check consistency of sheets to assess if all materials are bonded (non-friable) before conducting a B class removal. | | | |

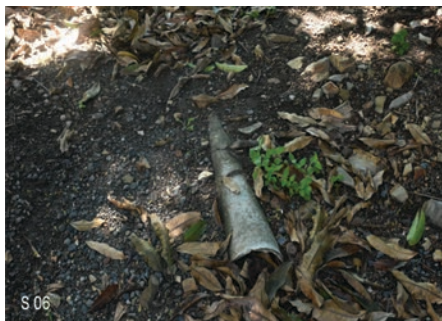
| <b>Condition:</b> | Fair | | <b>Class:</b> | Bonded (non-friable) |
| <b>Quantity:</b> | 0.8 m exposed, however rest of pipe conceal in earth | | <b>Type:</b> | Chrysotile<br>Amosite<br>Crocidolite |
| <b>Photographs:</b> | | | COHLABS Certificate of Analysis<br>Number 24-4489 Lab ID: 002 | |

| <b>Recommendations:</b> | Remove under Class B controls | | | |
