## 2024 ASBESTOS REGISTER – FLORENCE HOUSE, Rockhampton Girls Grammar School

Date of register: 06/06/2024

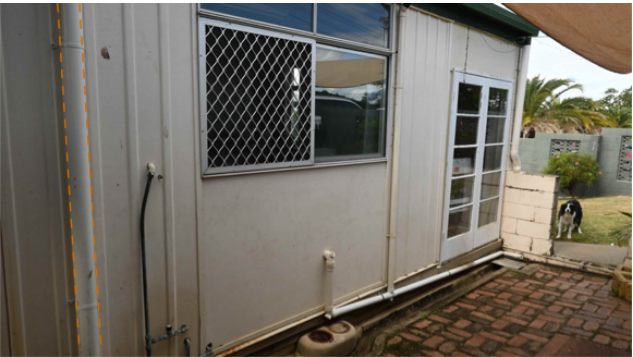
Photo 4 - cement fibre infill sheet below window - southern elevation
