## Asbestos Management Plan for Rockhampton Girls Grammar School Facilities 2024

**Version 1.1 – 26/07/2024**

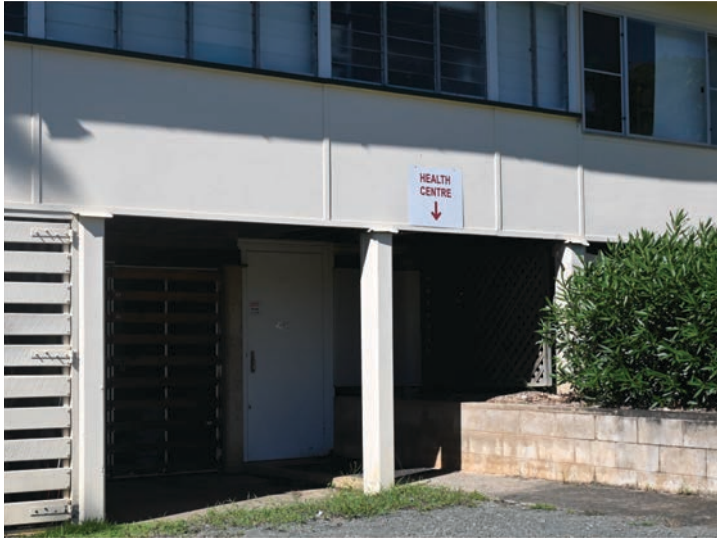
*Photograph 3 Original entry was ground floor*

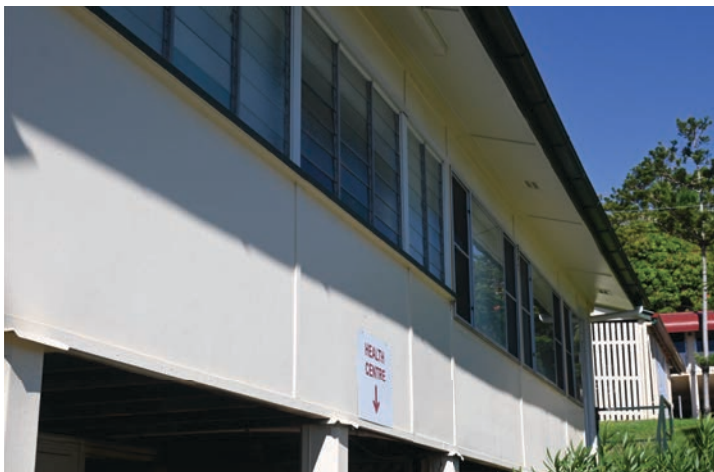
*Photograph 4 Entry via western end of building*

The 2024 inspection revealed that several of the items listed in the 2010 asbestos register were still present. Fortunately, these materials were found to be well-painted and in excellent condition.

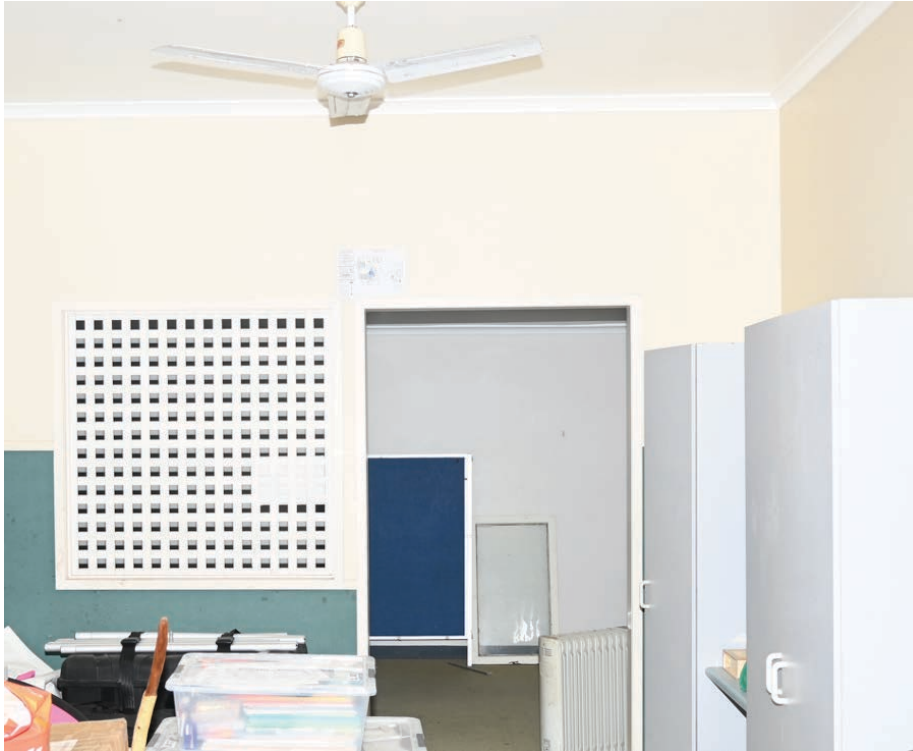
### Level 1 Storage Area of Paterson House:

*Photograph 10 Renovated office and storage areas on level one*

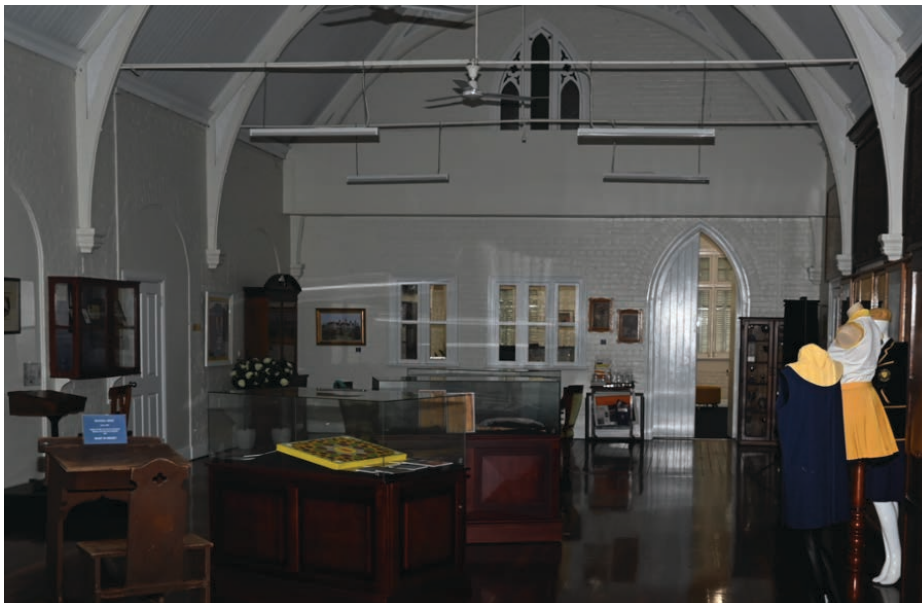
### Ground Floor Area of Paterson House:

*Photograph 11 Original building of brick, timber, and introduced materials.*

Policy is to sample any sheeting that is not confirmed to be made of modern material (renovated area) or of original timber and brick. Many areas of Paterson House were built before asbestos was used in building materials.

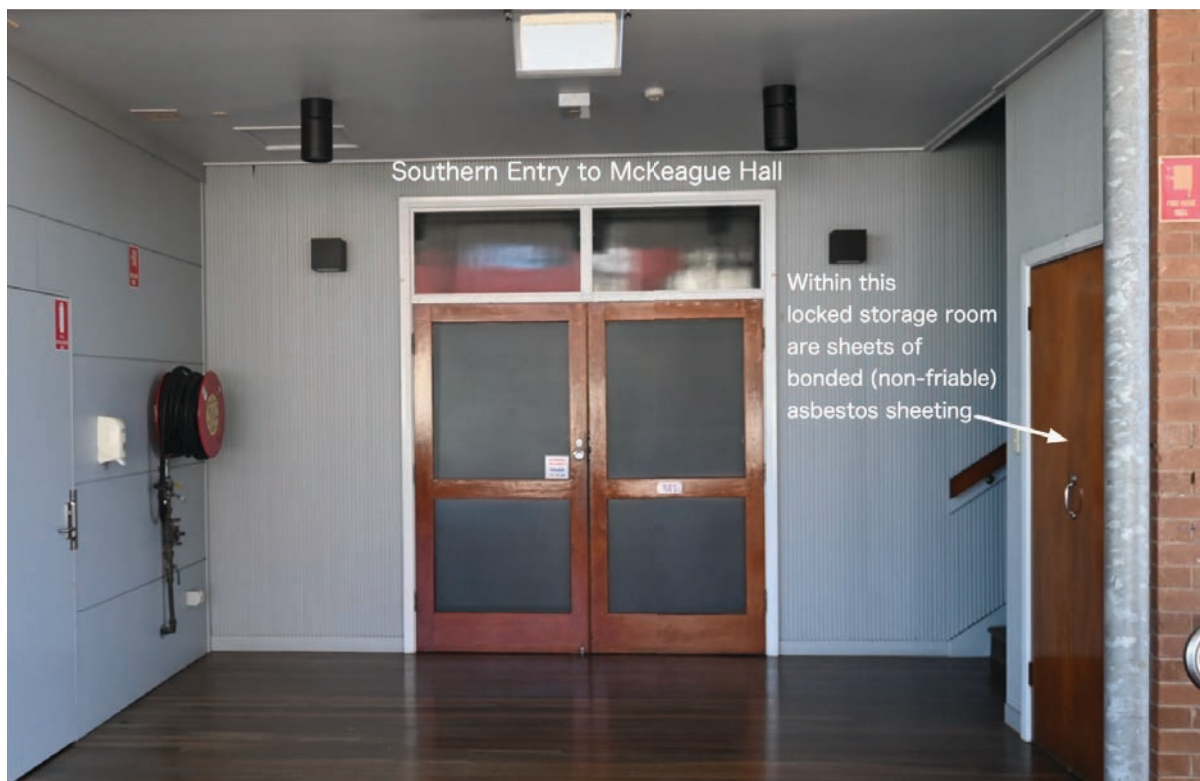
**2024 ASBESTOS REGISTER – McKeague Hall****One instance of residual ACM found:**

| <b>Sample Number:</b> | <b>2010</b> | <b>Location:</b> | Southern elevation, ground floor under stairs within locked storage room. | |
| <b>Application</b> | Wall and ceiling sheeting | | | |
