# ASBESTOS CLEARANCE CERTIFICATE

035-012\_031221

| Site address of work being carried out: | Rockhampton Girls Grammar<br>PATERSON BUILDING |
| Details of specific asbestos removal work area(s): | Removal of wall sheeting to cool room - 4m2<br><b>Please see clearance inspection Notes</b> |

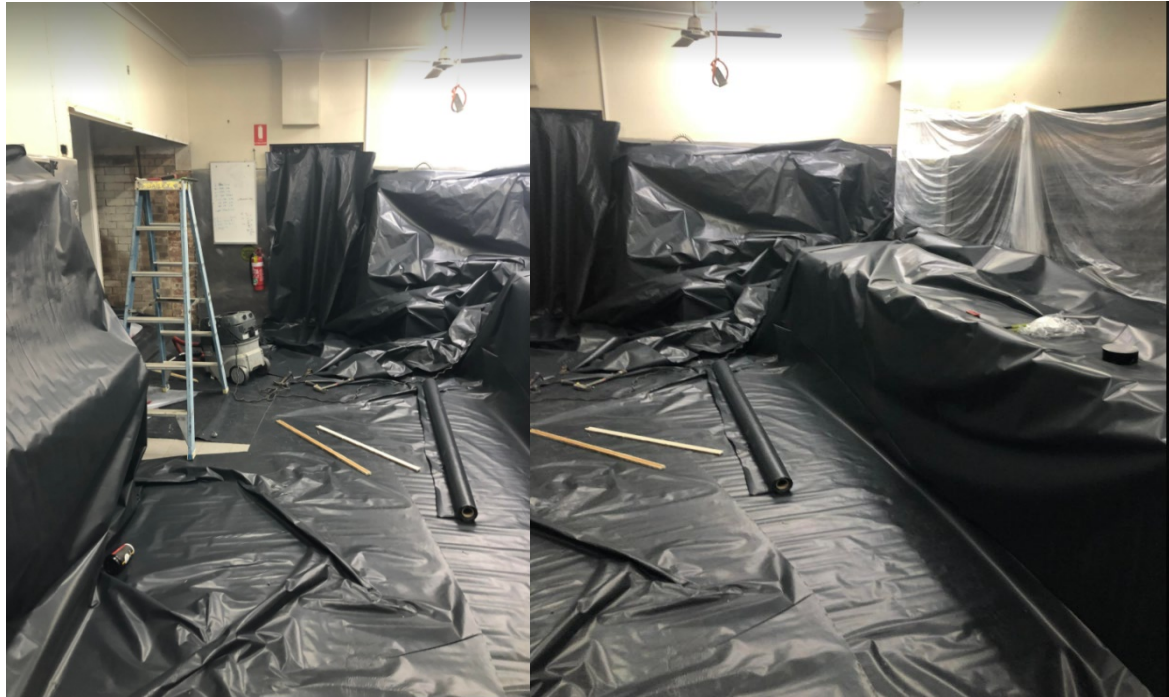
Plastic Arpons

| NOTE # | DETAILS |
|---|---|
| 3. | 200um plastic were deployed to encapsulate removal area (see attachments below) |

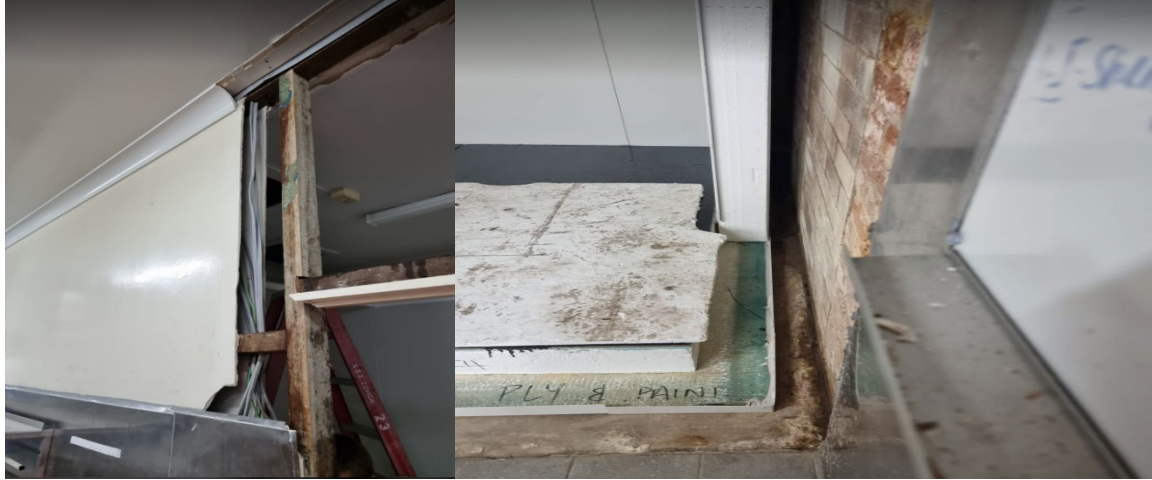
At time of clearance

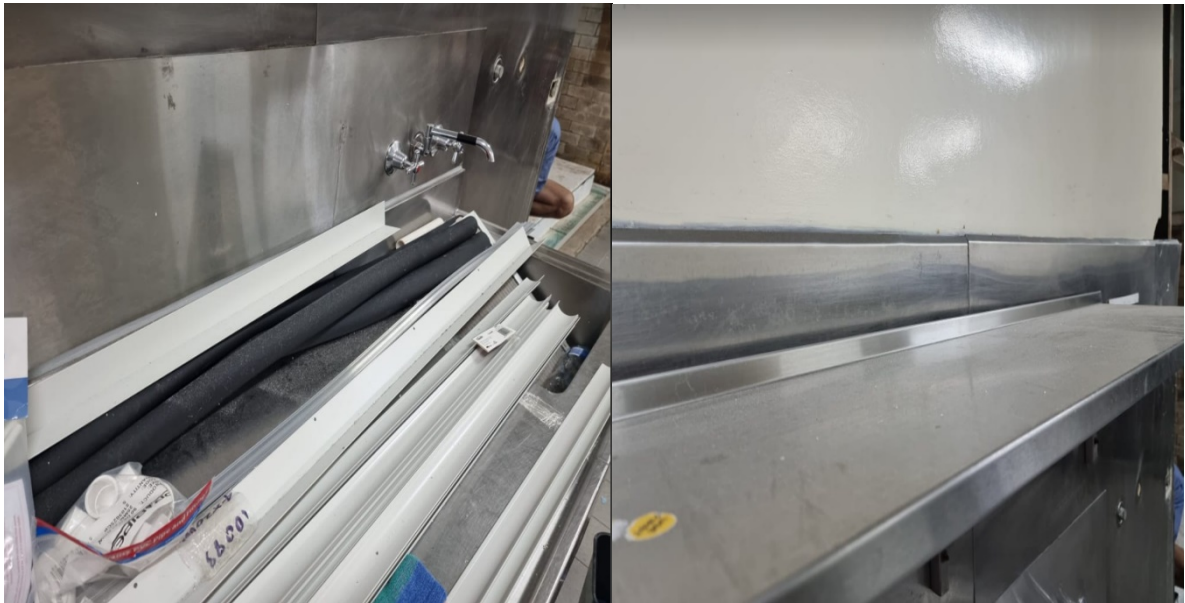
Legacy dust prior to removal

| NOTE # | DETAILS |
|---|---|
| 2. | Legacy dust was observed prior to removal TDA take no warranty from works done prior to TDA commencement |
