## 2024 ASBESTOS REGISTER – JACKSON HOUSE (Building 24), Rockhampton Girls Grammar School

Date of register: 06/06/2024

## 2024 ASBESTOS REGISTER – FLORENCE HOUSE, Rockhampton Girls Grammar School

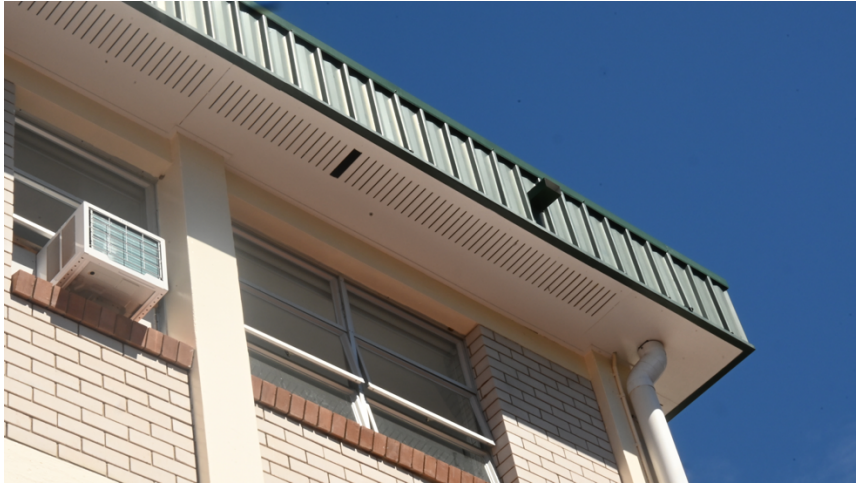
| 09/04/2024 | - | Presumed Chrysotile >30m² | Non-friable | Fair | Exterior:<br><br>Upper most level – Soffits | Unable to access due to working at height restriction. Material of same appearance tested at Luck Building and found to contain Chrysotile asbestos. |

*Photo 1 - Soffit of Upper Level - Presumed Asbestos Based on Testing Elsewhere*
